APPENDIX BIO

BIOLOGICAL RESOURCE DOCUMENTS

Montrose Environmental Solutions
60th Street and 122nd Avenue Parcels
Project #: 20241307
August 1, 2024

Appendix A | Figures

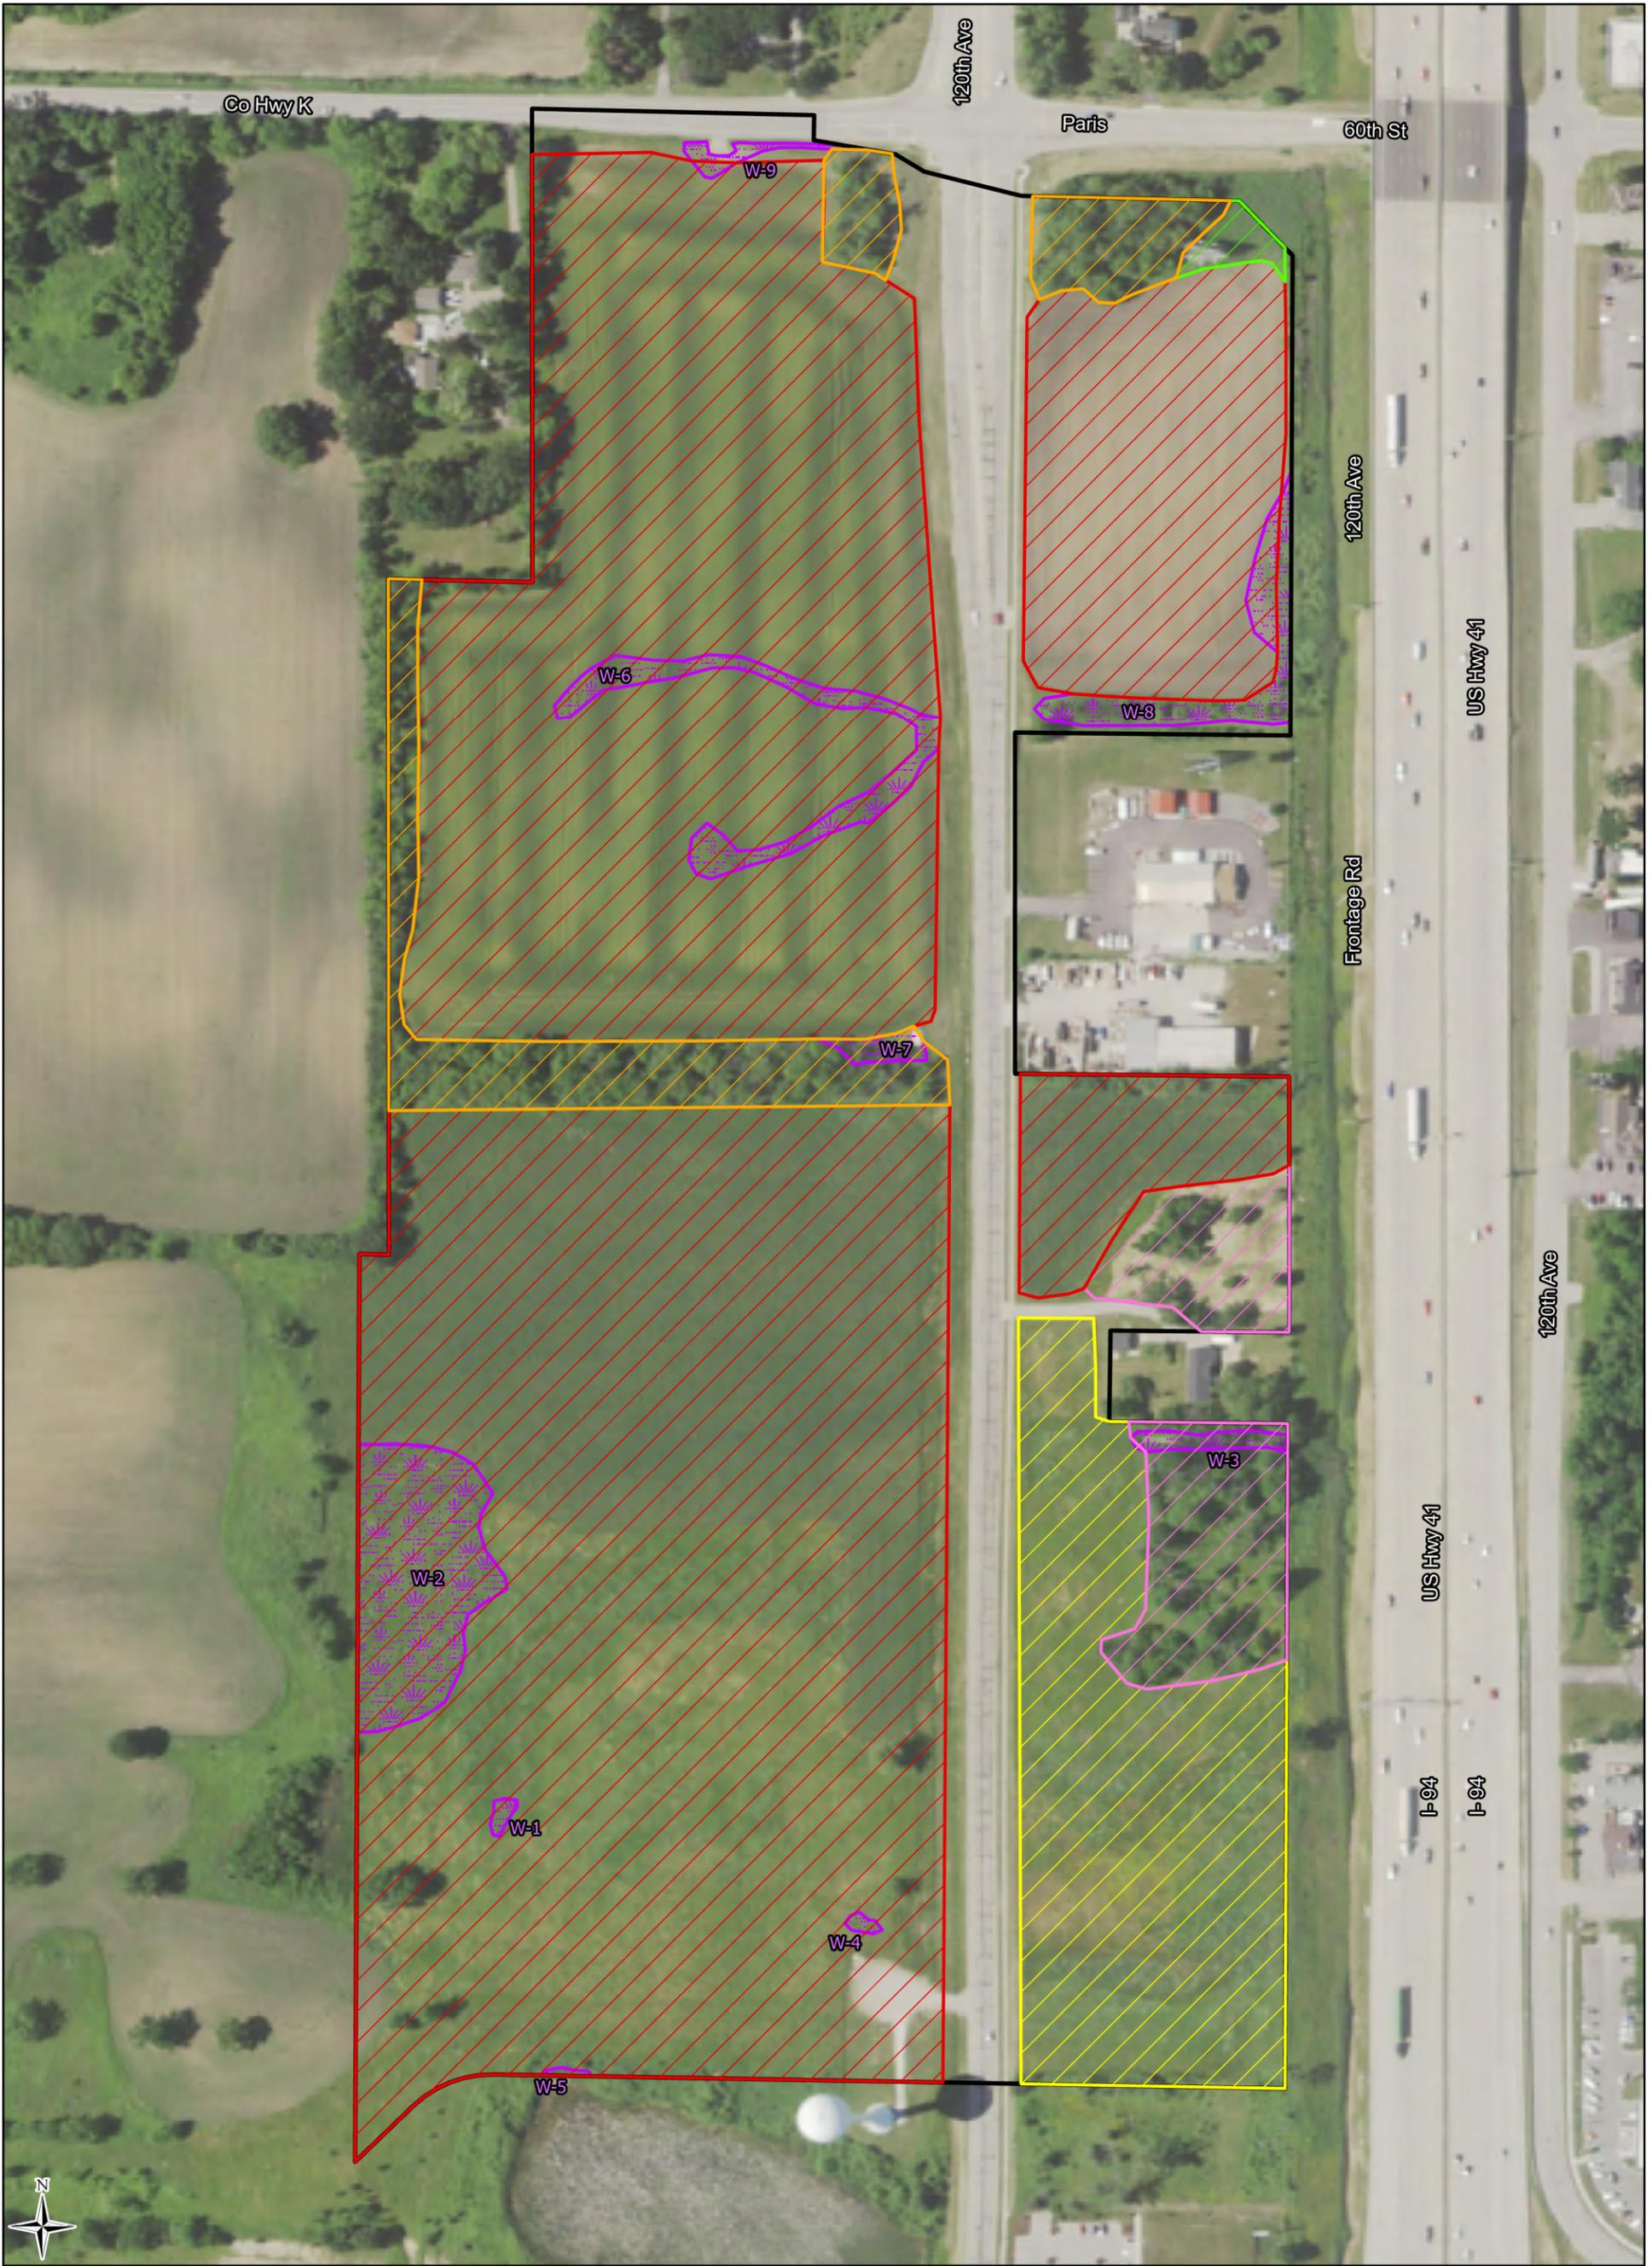
- Study Area (63.33 ac)
 - Field Delineated Wetland (2.64 ac)
- Plant Communities**
- Hay Field (5.84 ac)
 - Meadow w/ Scattered Trees (2.50 ac)
 - Old Field (44.14 ac)
 - Open Meadow (0.17 ac)
 - Woodland (2.96 ac)

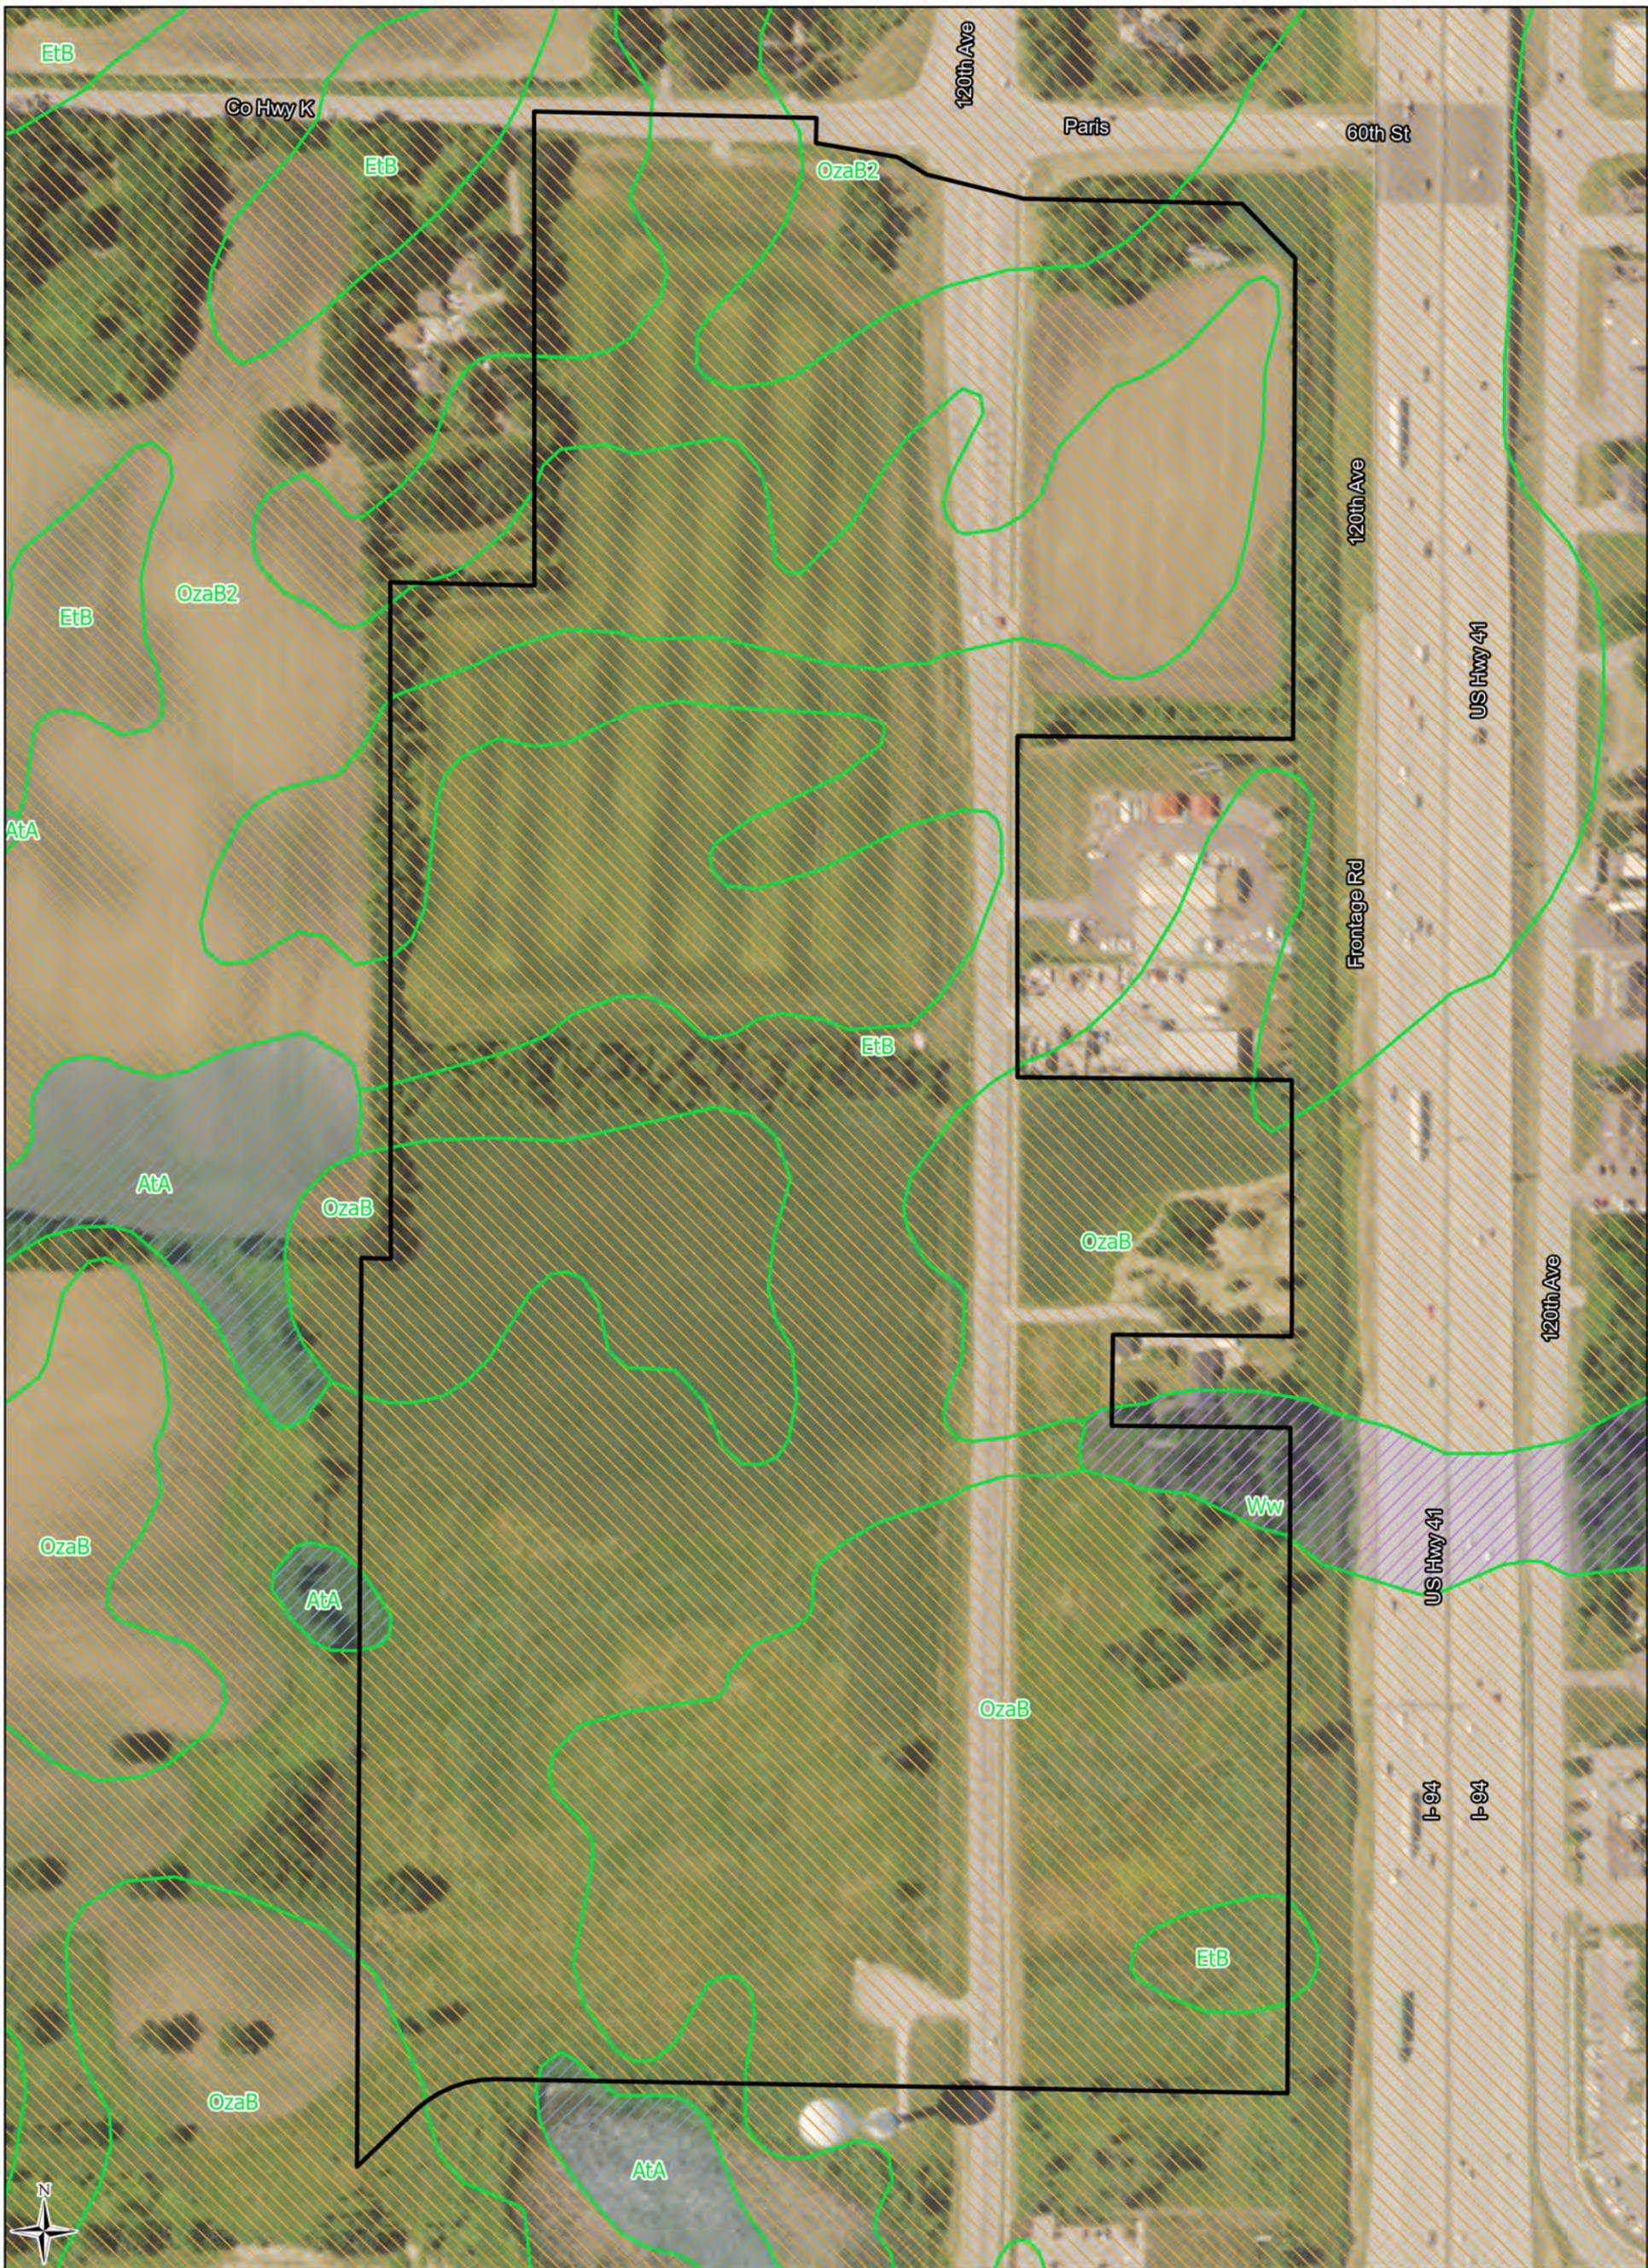
Figure 3. NRCS Hydric Soils
60th St. and 122nd Ave.
Project #20241307
T1N, R21E, S1
C Kenosha, Kenosha Co

- Study Area (63.33 ac)
- ### NRCS Soil Survey Data
- Hydric (100%)
 - Predominantly Hydric (85-99%)
 - Partially Hydric (16-84%)
 - Predominantly Non-Hydric (1-15%)
 - Non-Hydric (0%)

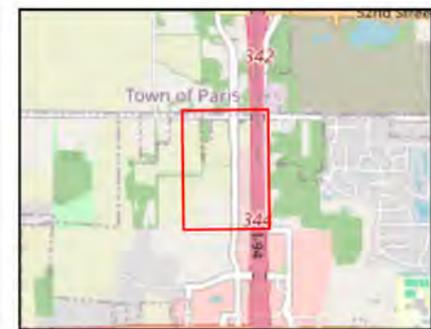
Soils mapped by the NRCS Soil Survey within the Study Area and their hydric status are summarized in Table 1. Wetlands identified during the field investigation are located primarily within areas mapped as hydric or partially hydric soils including wetland indicator soils (Figures 3 and 4, Appendix A).

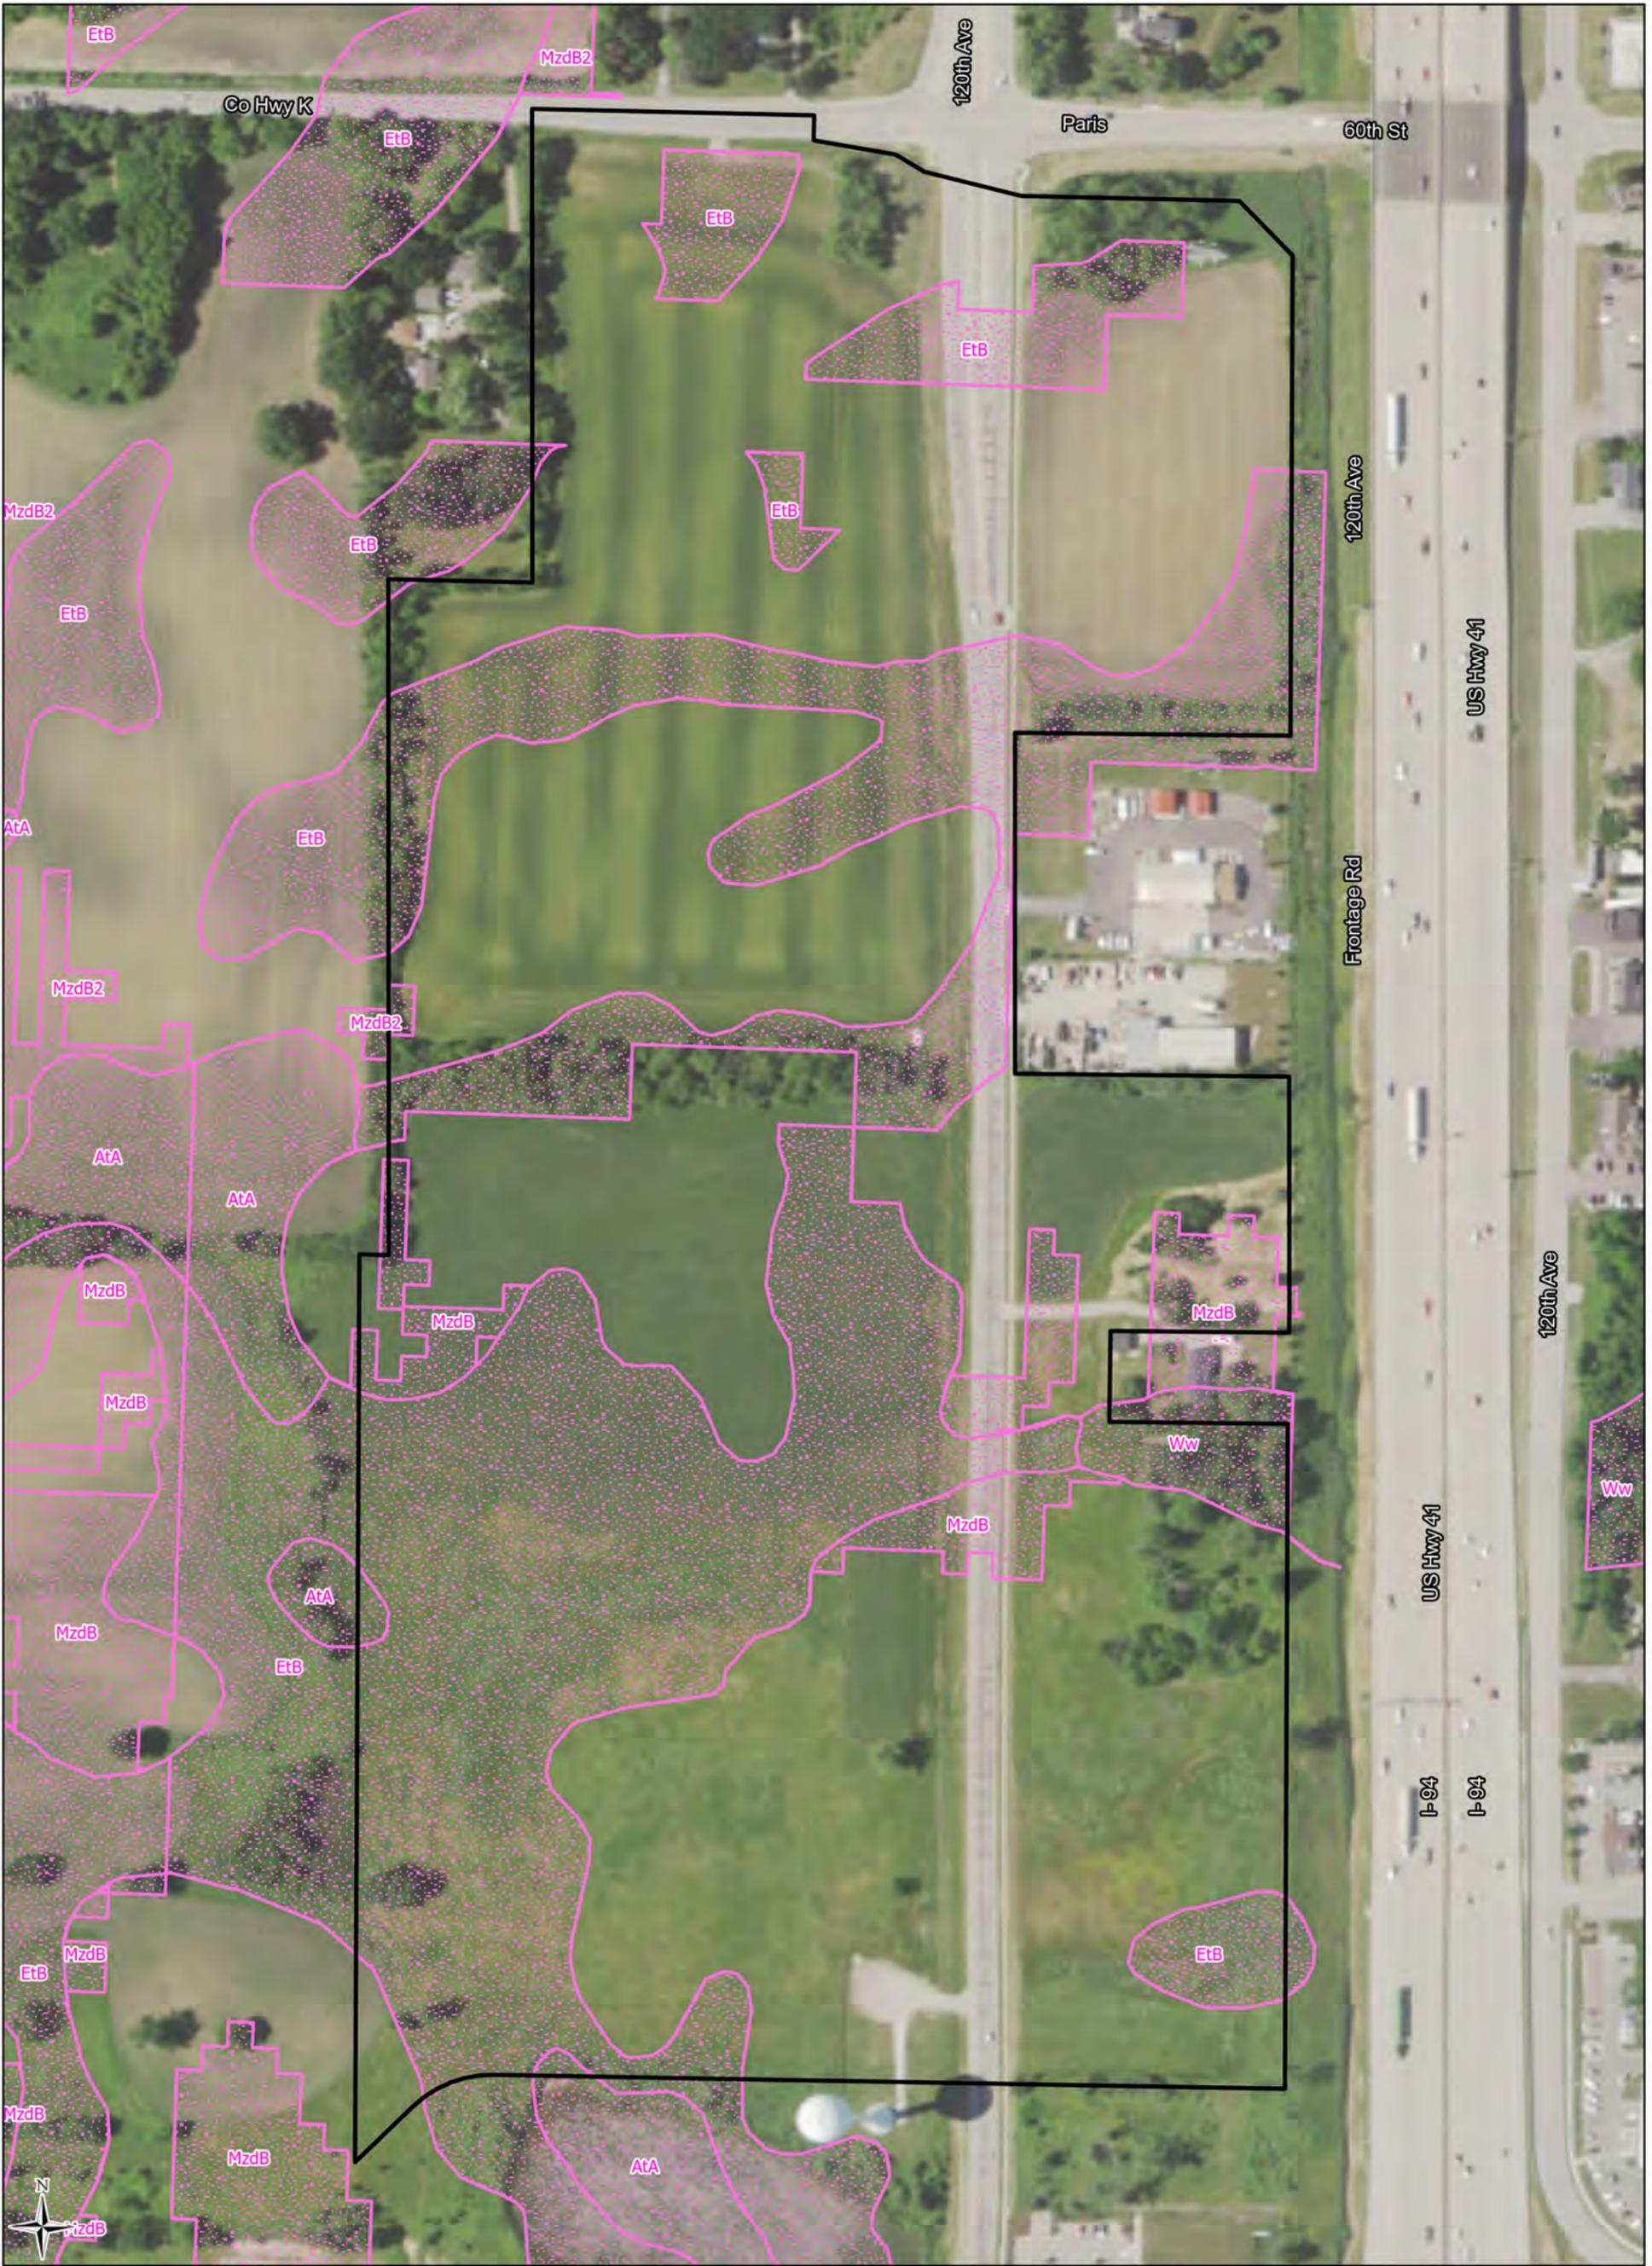
Figure 4. SWDV Wetland Indicators
 60th St. and 122nd Ave.
 Project #20241307
 T1N, R21E, S1
 C Kenosha, Kenosha Co

Study Area (63.33 ac)
 SWDV Wetland Indicators

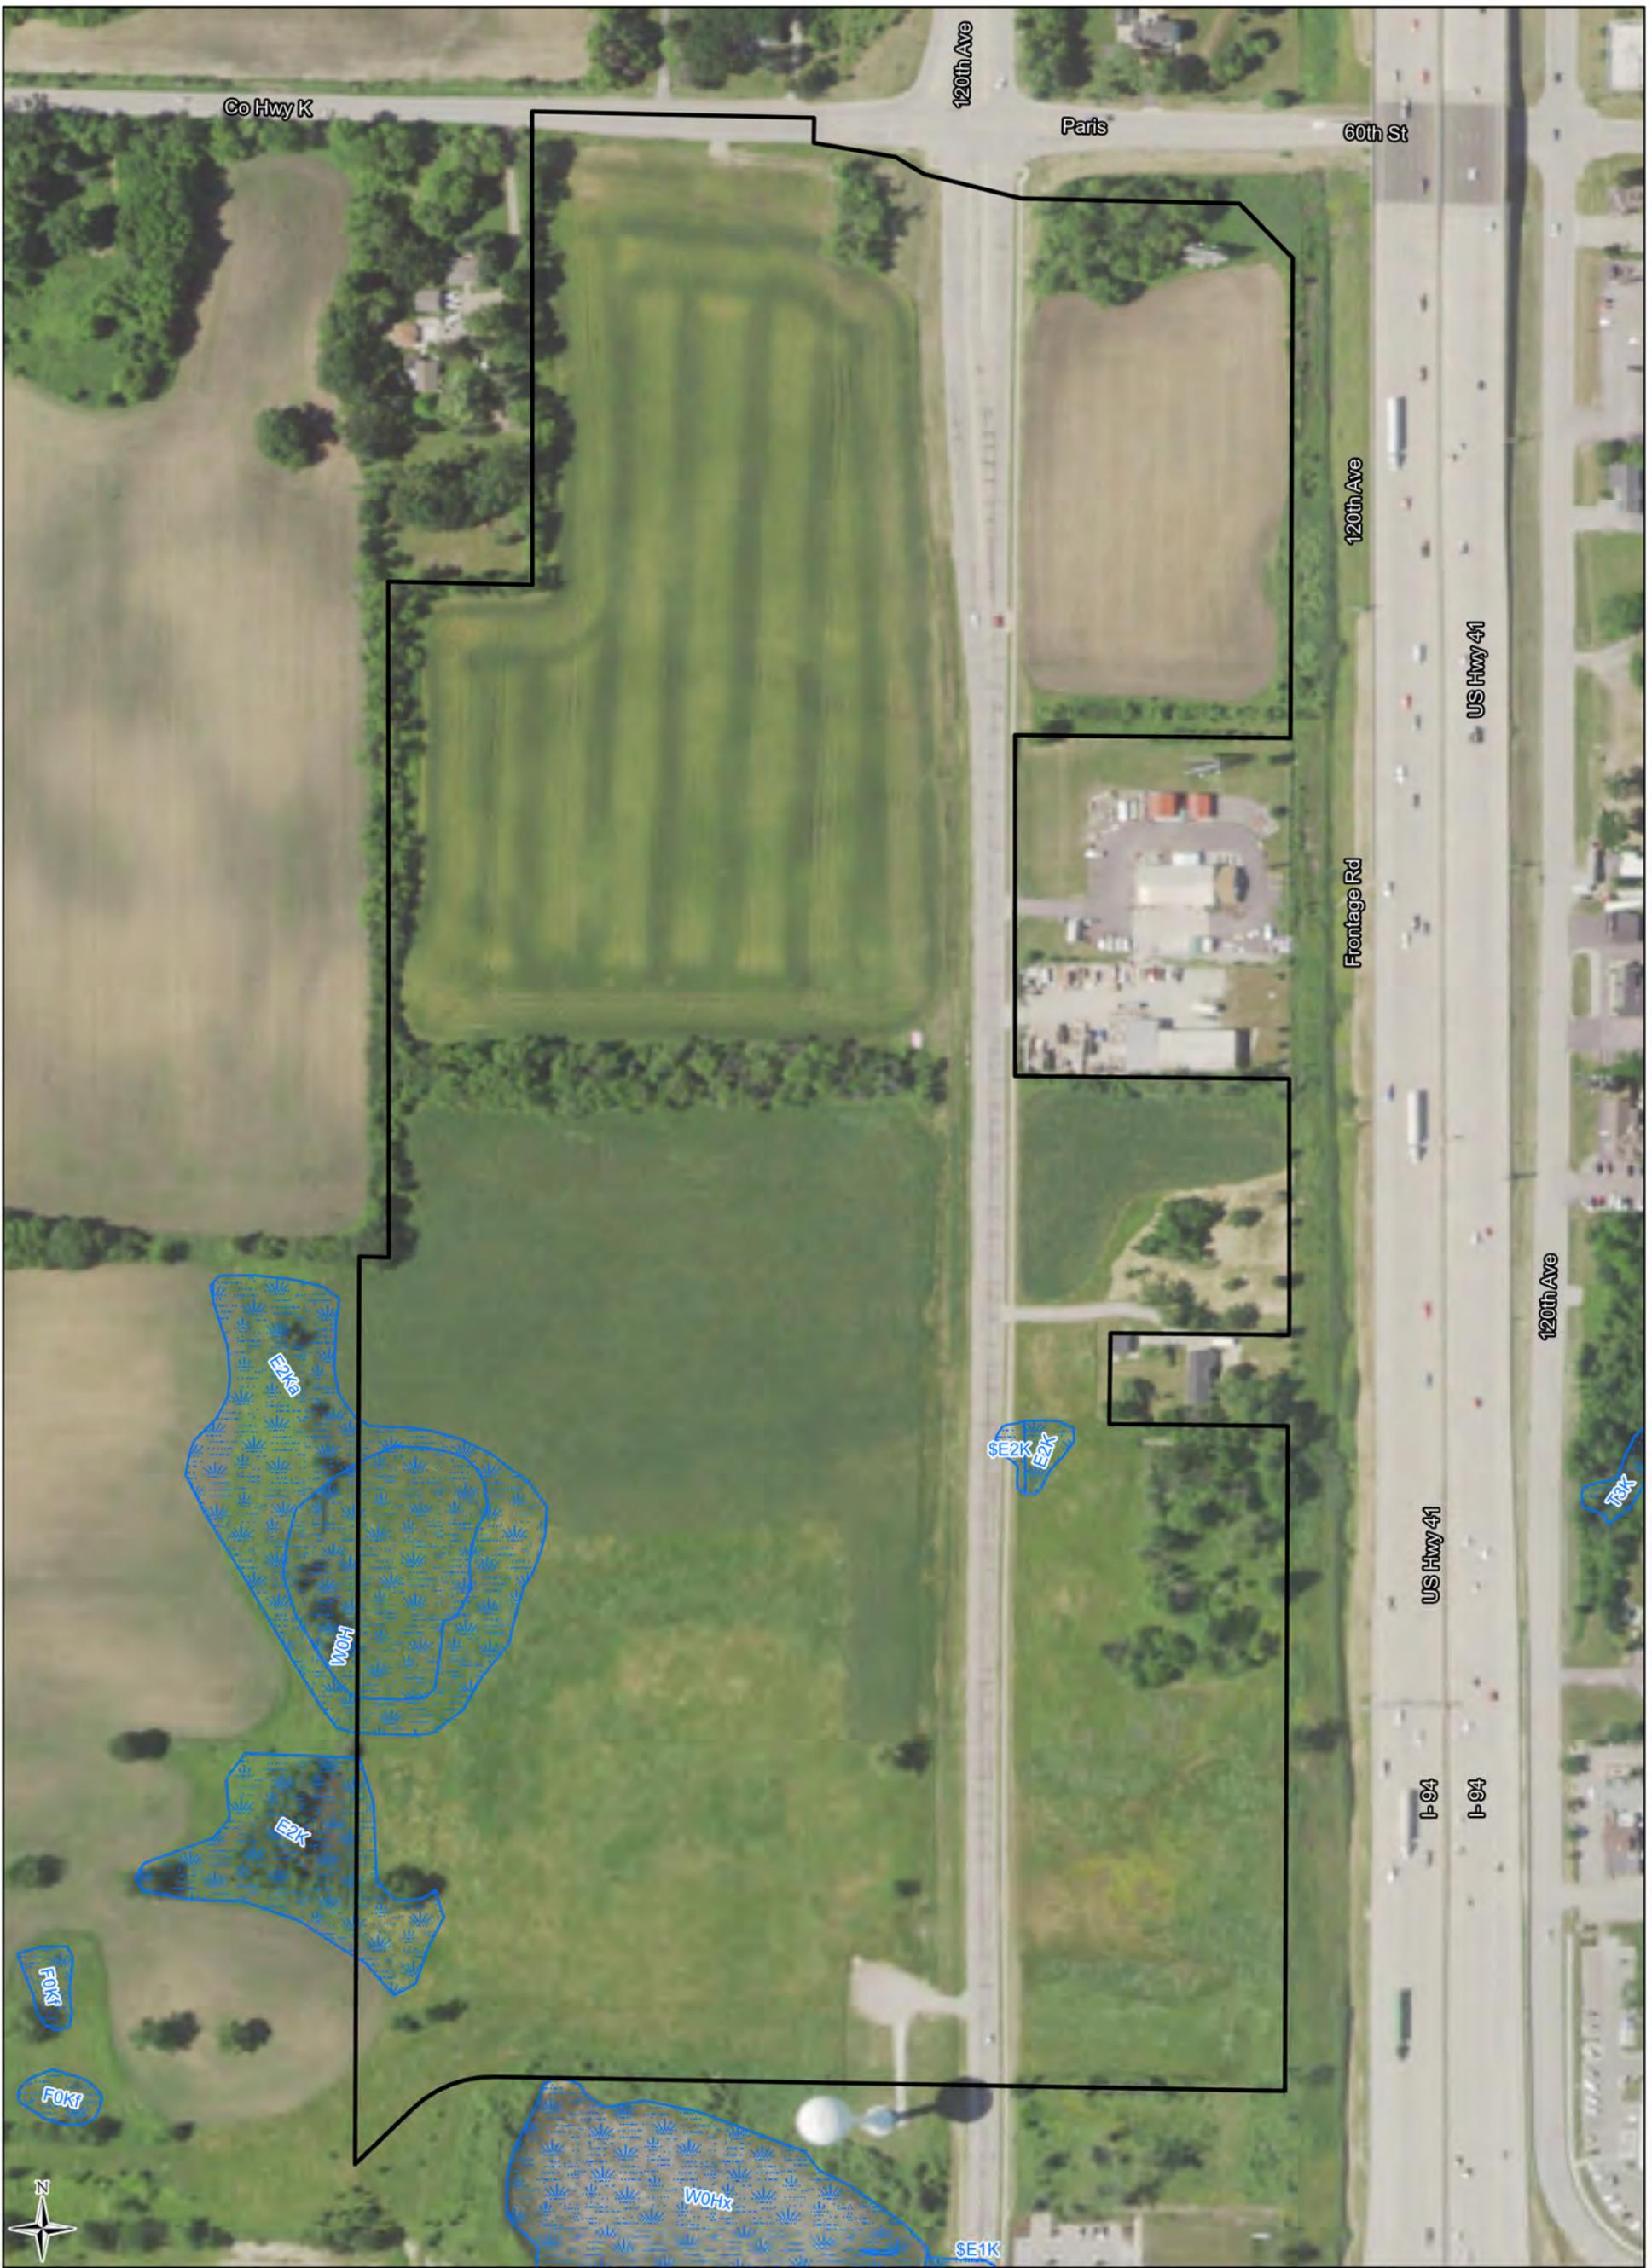
Figure 5. Wisconsin Wetland Inventory
60th St. and 122nd Ave.
Project #20241307
T1N, R21E, S1
C Kenosha, Kenosha Co

- Study Area (63.33 ac)
- WWI Polygons
- WWI Points
- Perennial Streams (None in Map Extent)
- Intermittent Streams (None in Map Extent)
- Waterbodies (None in Map Extent)

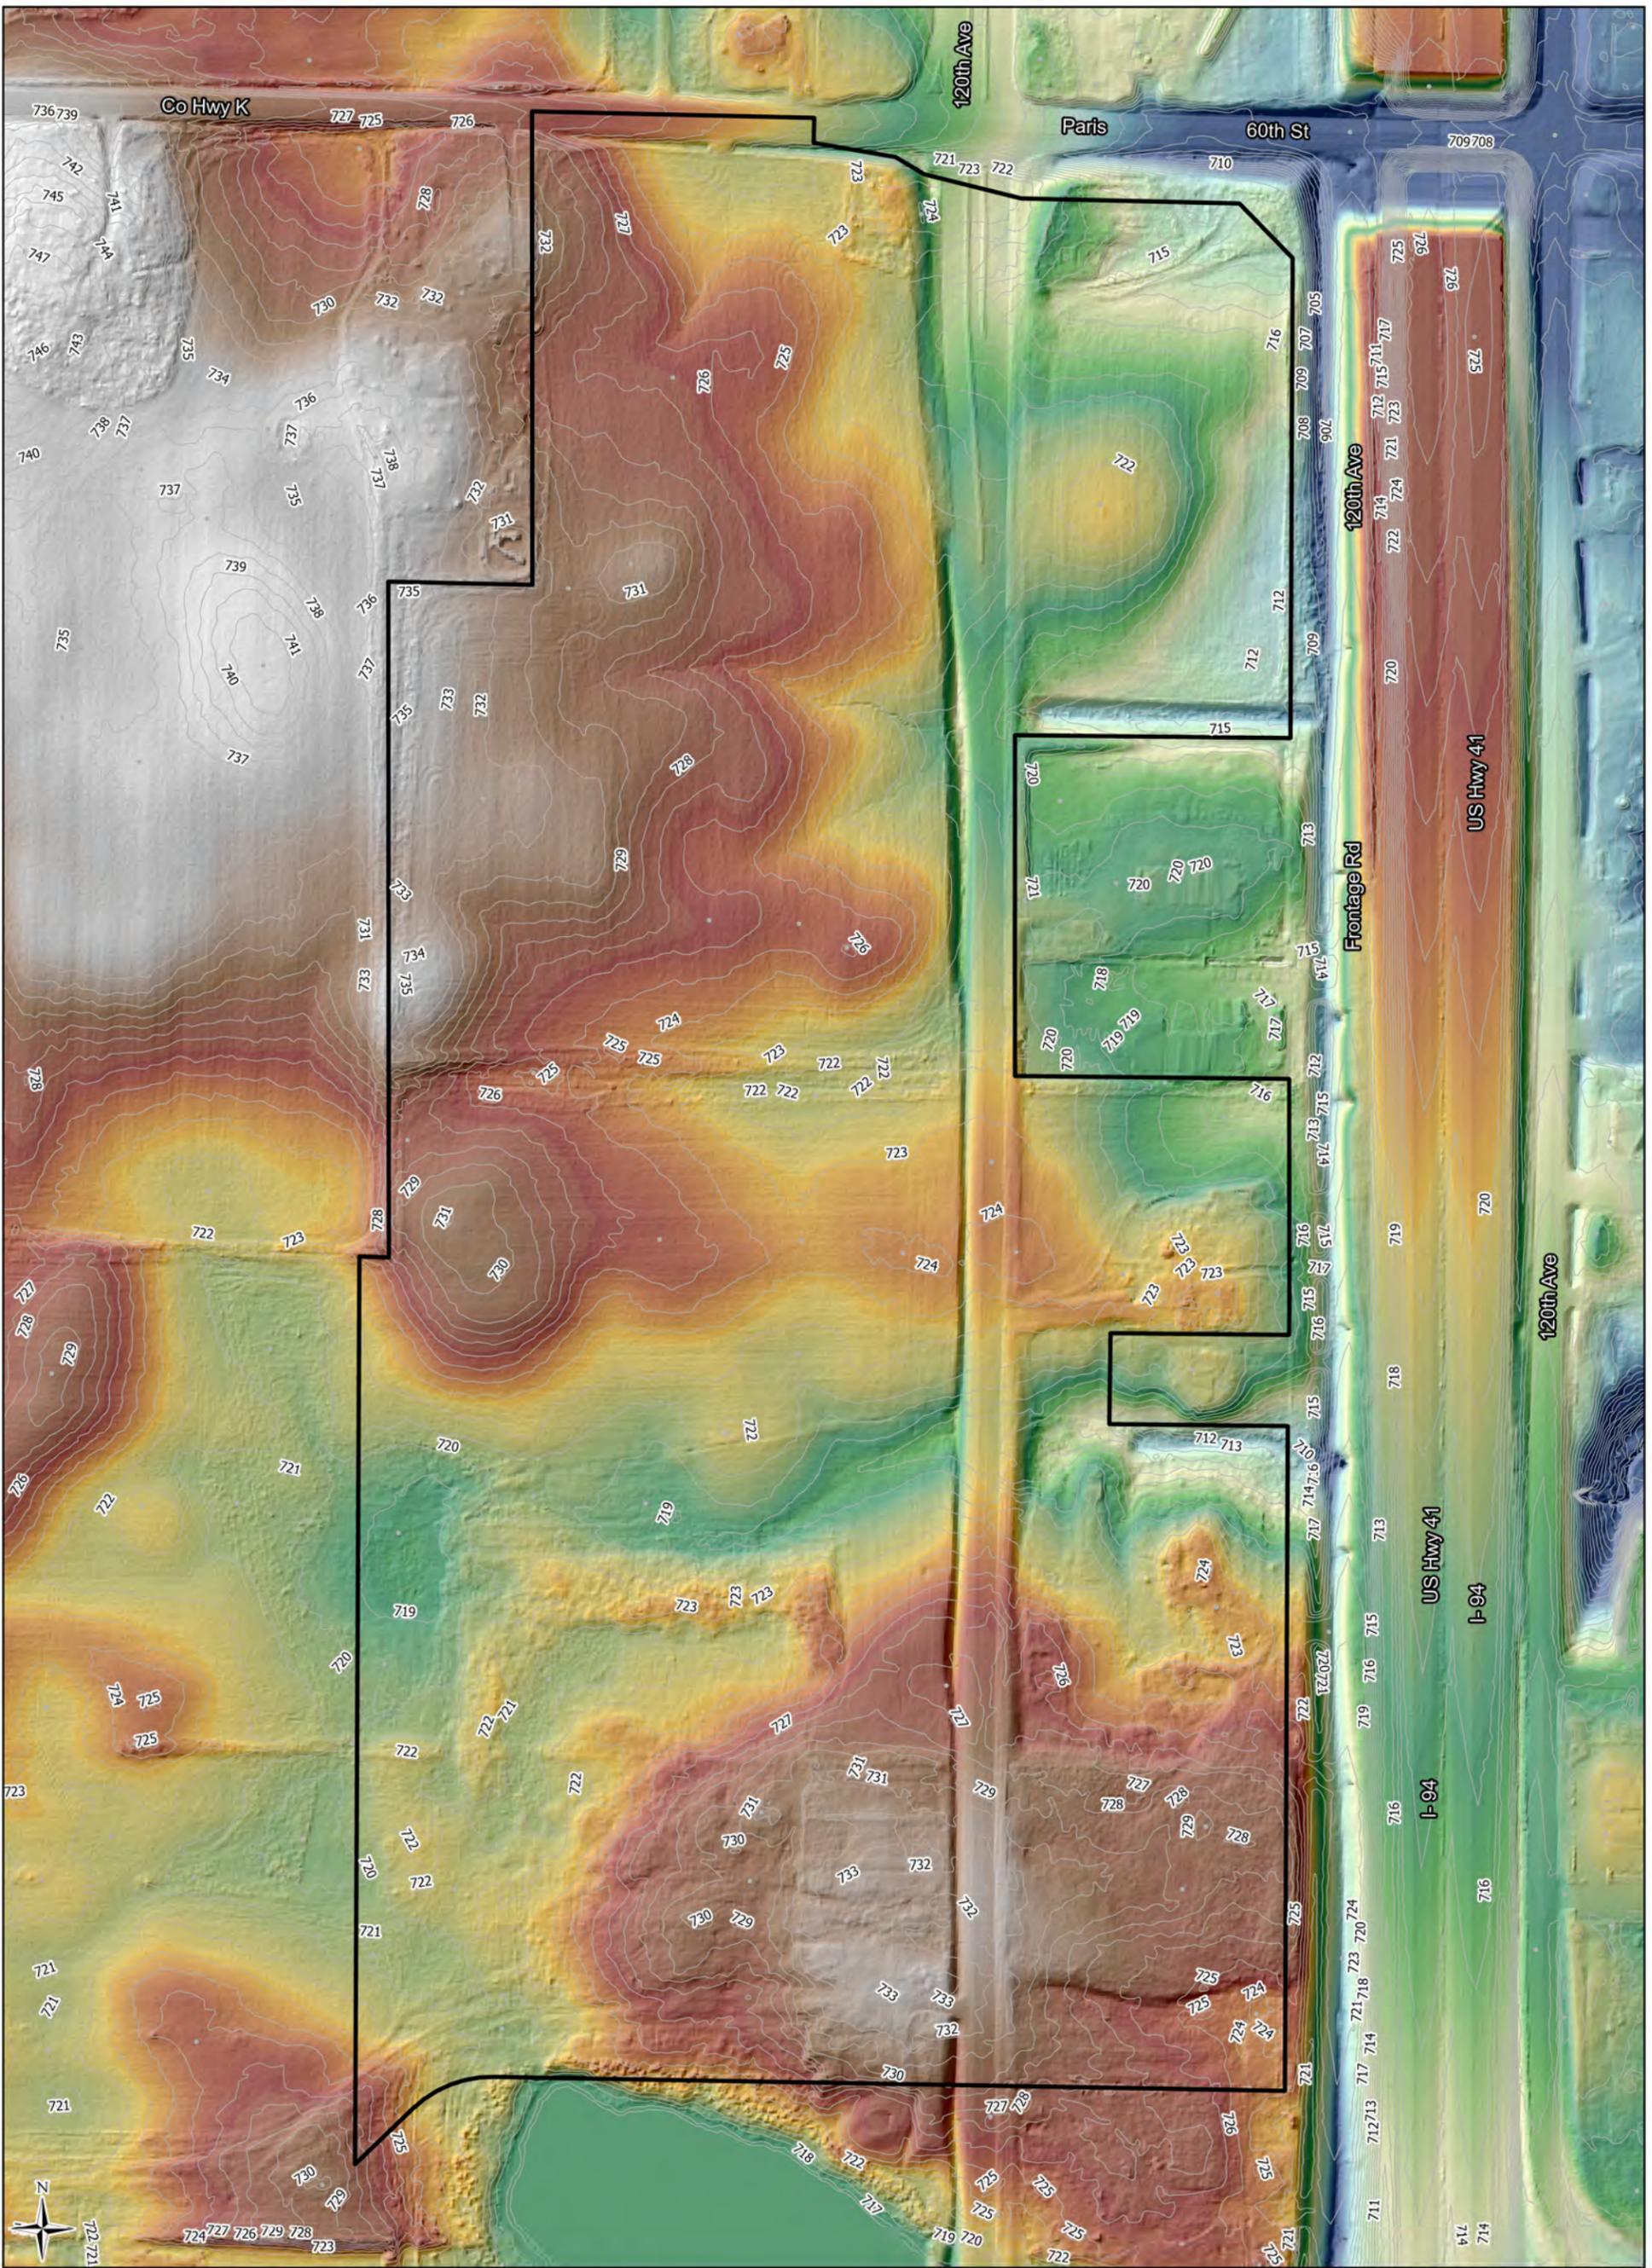
Figure 6. Color-Stretch
 Digital Elevation Model
 60th St. and 122nd Ave.
 Project #20241307
 T1N, R21E, S1
 C Kenosha, Kenosha Co

Study Area (63.33 ac)
~ Kenosha Co 1' Contours

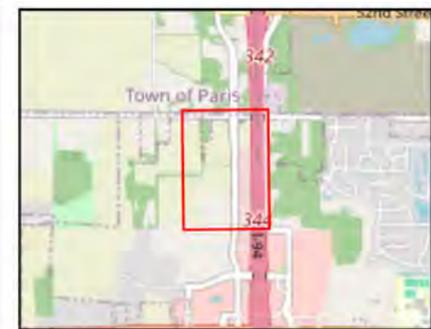
The topography within the Study Area was rolling, with various hills, depressions, and slopes. A topographic high of approximately 735 feet above mean sea level (msl) is present on the west side, and a topographic low of approximately 712 feet above msl is present near the northeast corner (Figures 2, 6, and 7 Appendix A). Land uses within the Study
