APPENDIX BIO

BIOLOGICAL RESOURCE DOCUMENTS

Montrose Environmental Solutions
60th Street and 122nd Avenue Parcels
Project #: 20241307
August 1, 2024

Appendix A | Figures

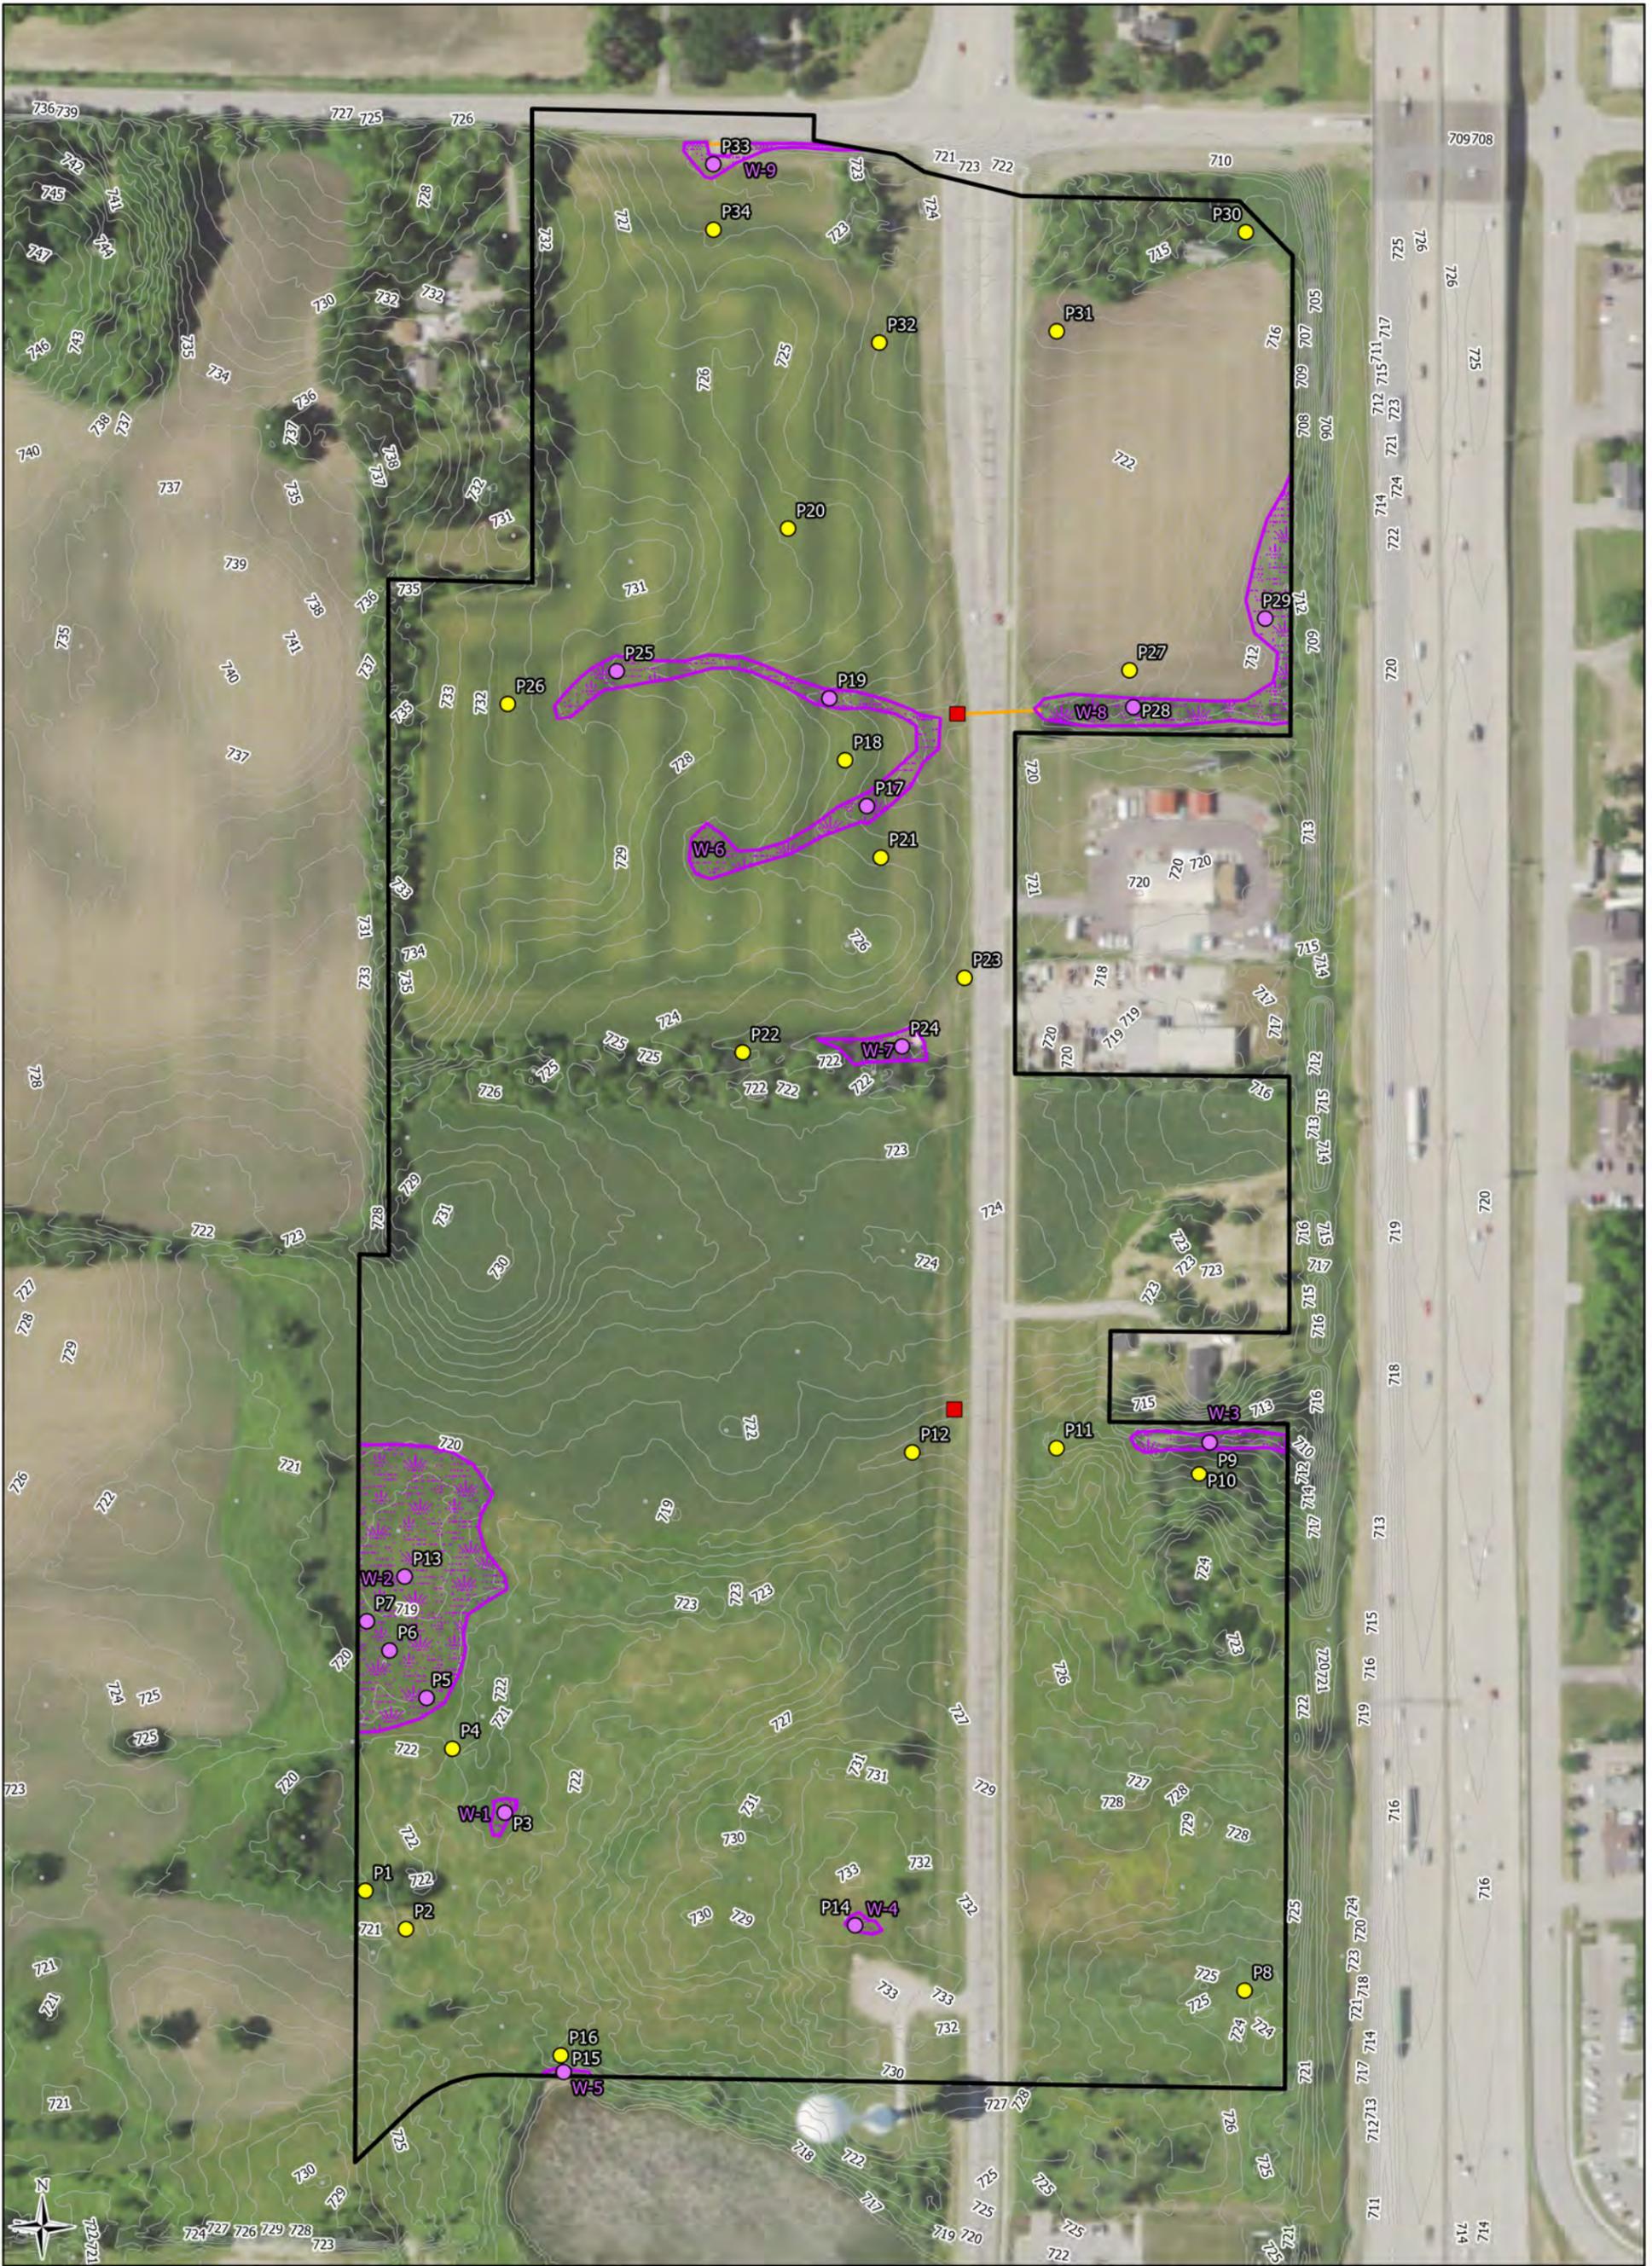
- Study Area (63.33 ac)
 - Field Delineated Wetland (2.64 ac)
 - Culvert
 - Kenosha Co 1' Contours
 - Storm Drain
- Sample Points**
- Upland
 - Wetland

Nine (9) wetland areas totaling approximately 2.64 acres were delineated and mapped within the Study Area (Figure 7, Appendix A). No waterways or water bodies were observed in the Study Area. A pond was observed immediately south of the Study Area.

Nine (9) wetlands were identified and delineated within the Study Area. Wetland determination data sheets (Appendix C) were completed at 34 sample points that were representative of the wetland and upland conditions near the boundary and where potential wetlands may be present based on the desktop review and field reconnaissance. Appendix D provides photographs, typically at the sample point locations of the wetlands and adjacent uplands. The wetland boundary and sample point locations are shown on Figure 7 (Appendix A) and the wetlands are summarized in Table 2 and detailed in the following sections.

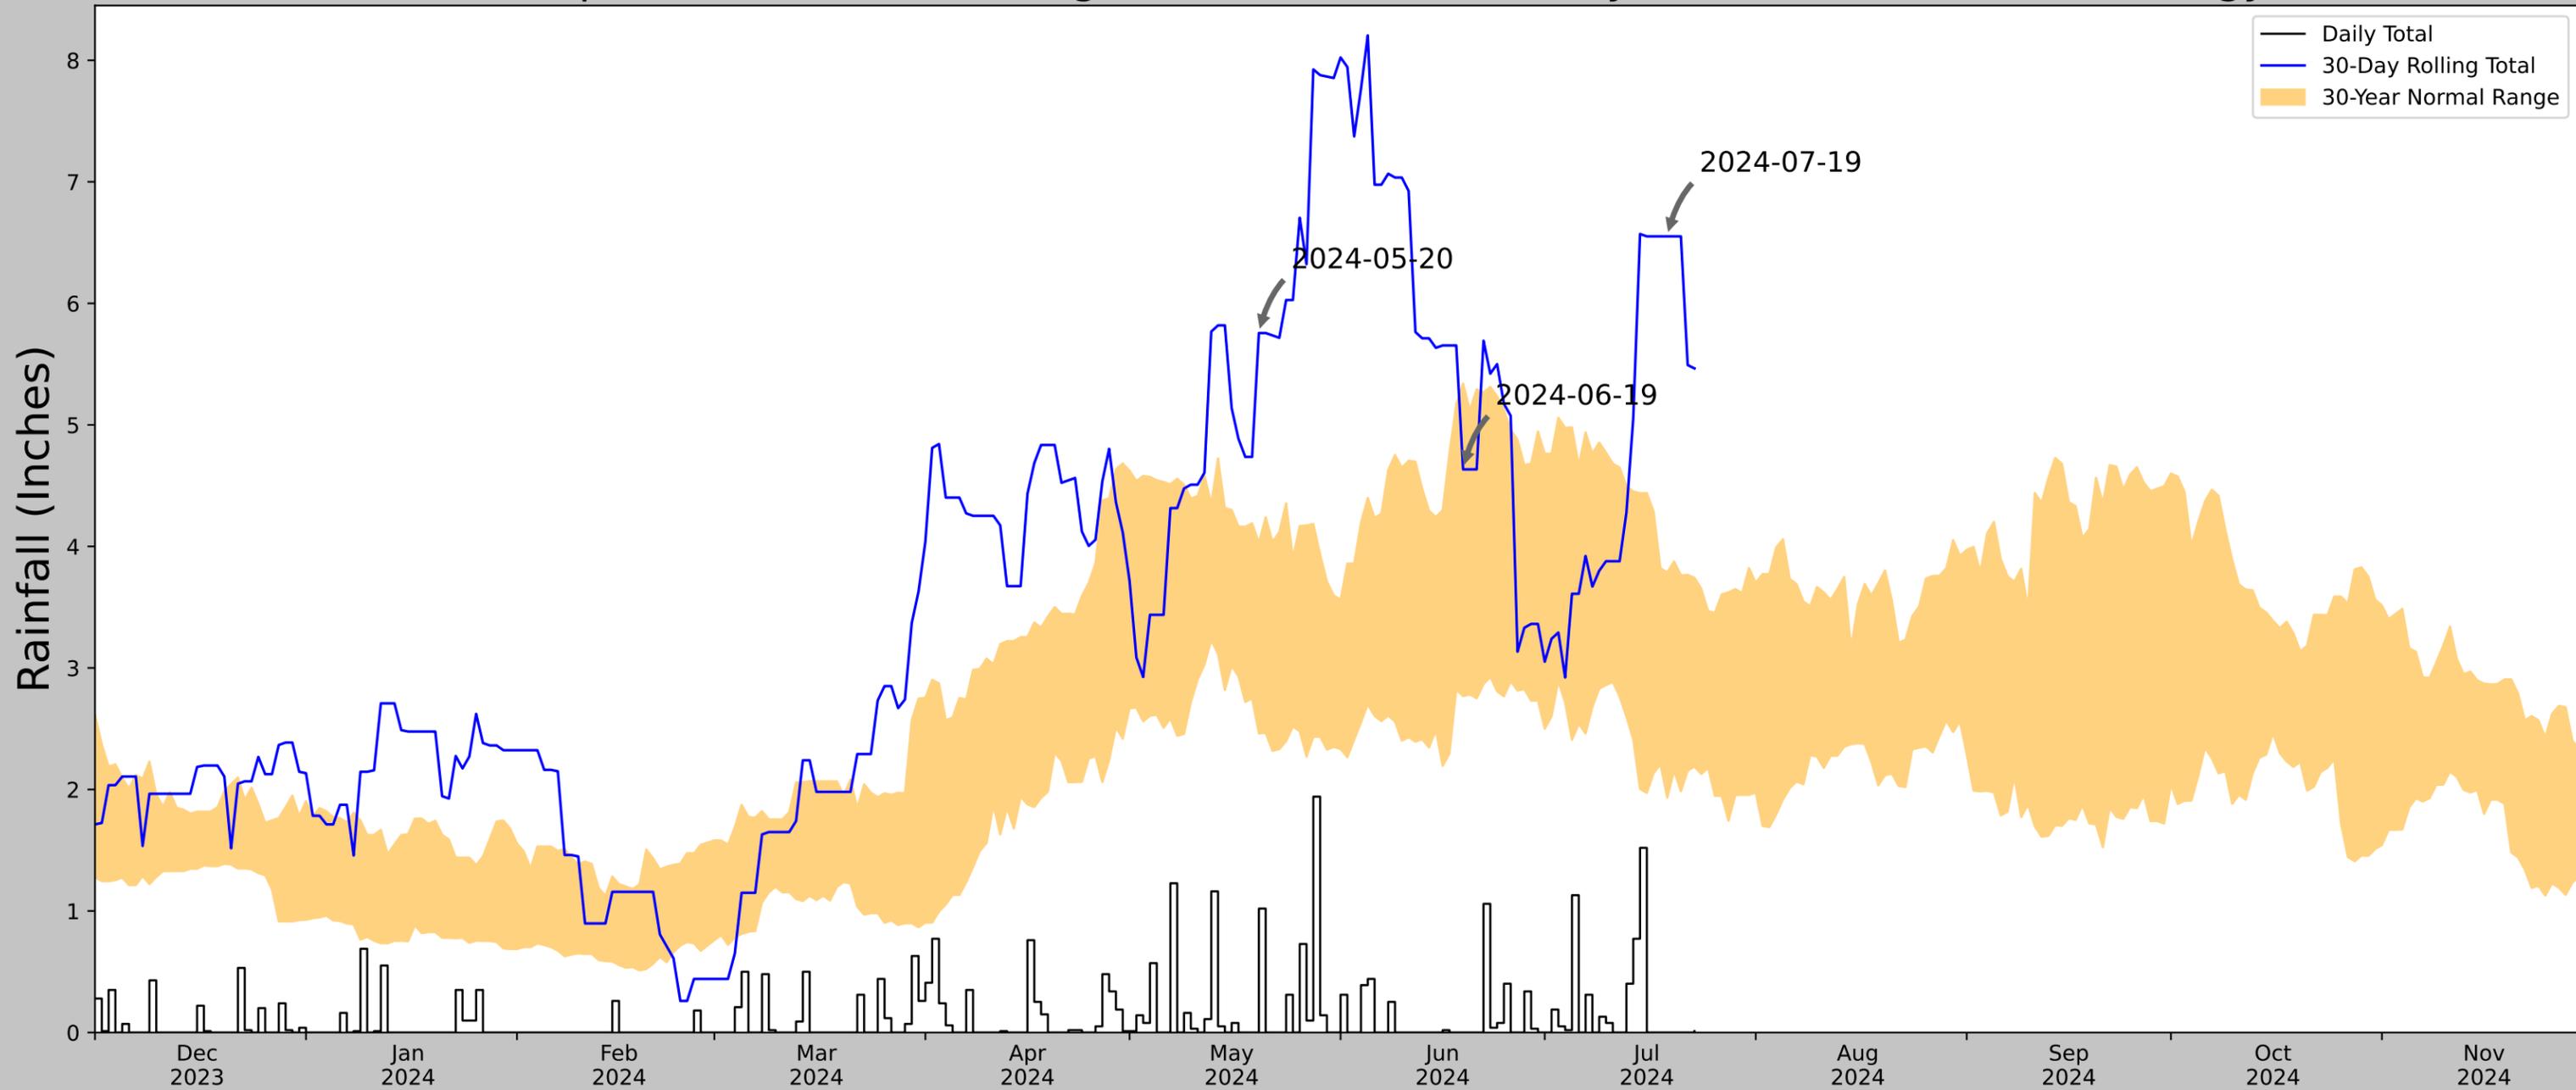
Antecedent Precipitation vs Normal Range based on NOAA's Daily Global Historical Climatology Network

| Coordinates | 42.575908, -87.958131 |
| Observation Date | 2024-07-19 |

According to the APT analysis using the previous 90 days of precipitation data, conditions encountered at the time of the fieldwork were expected to be wetter than normal for the time of year (Appendix B). The Palmer Drought Severity Index was checked as part of the APT analysis, and the long-term conditions at the time of the fieldwork were in the moderate wetness range. Fieldwork was completed within the dry-season based on long-term regional hydrology data utilized in the WebWIMP Climatic Water Balance and computed as part of the APT analysis. Conditions on site were observed to be wet, approximately 2.69 inches of rain had fallen within a week of the first day of fieldwork on July 19th.

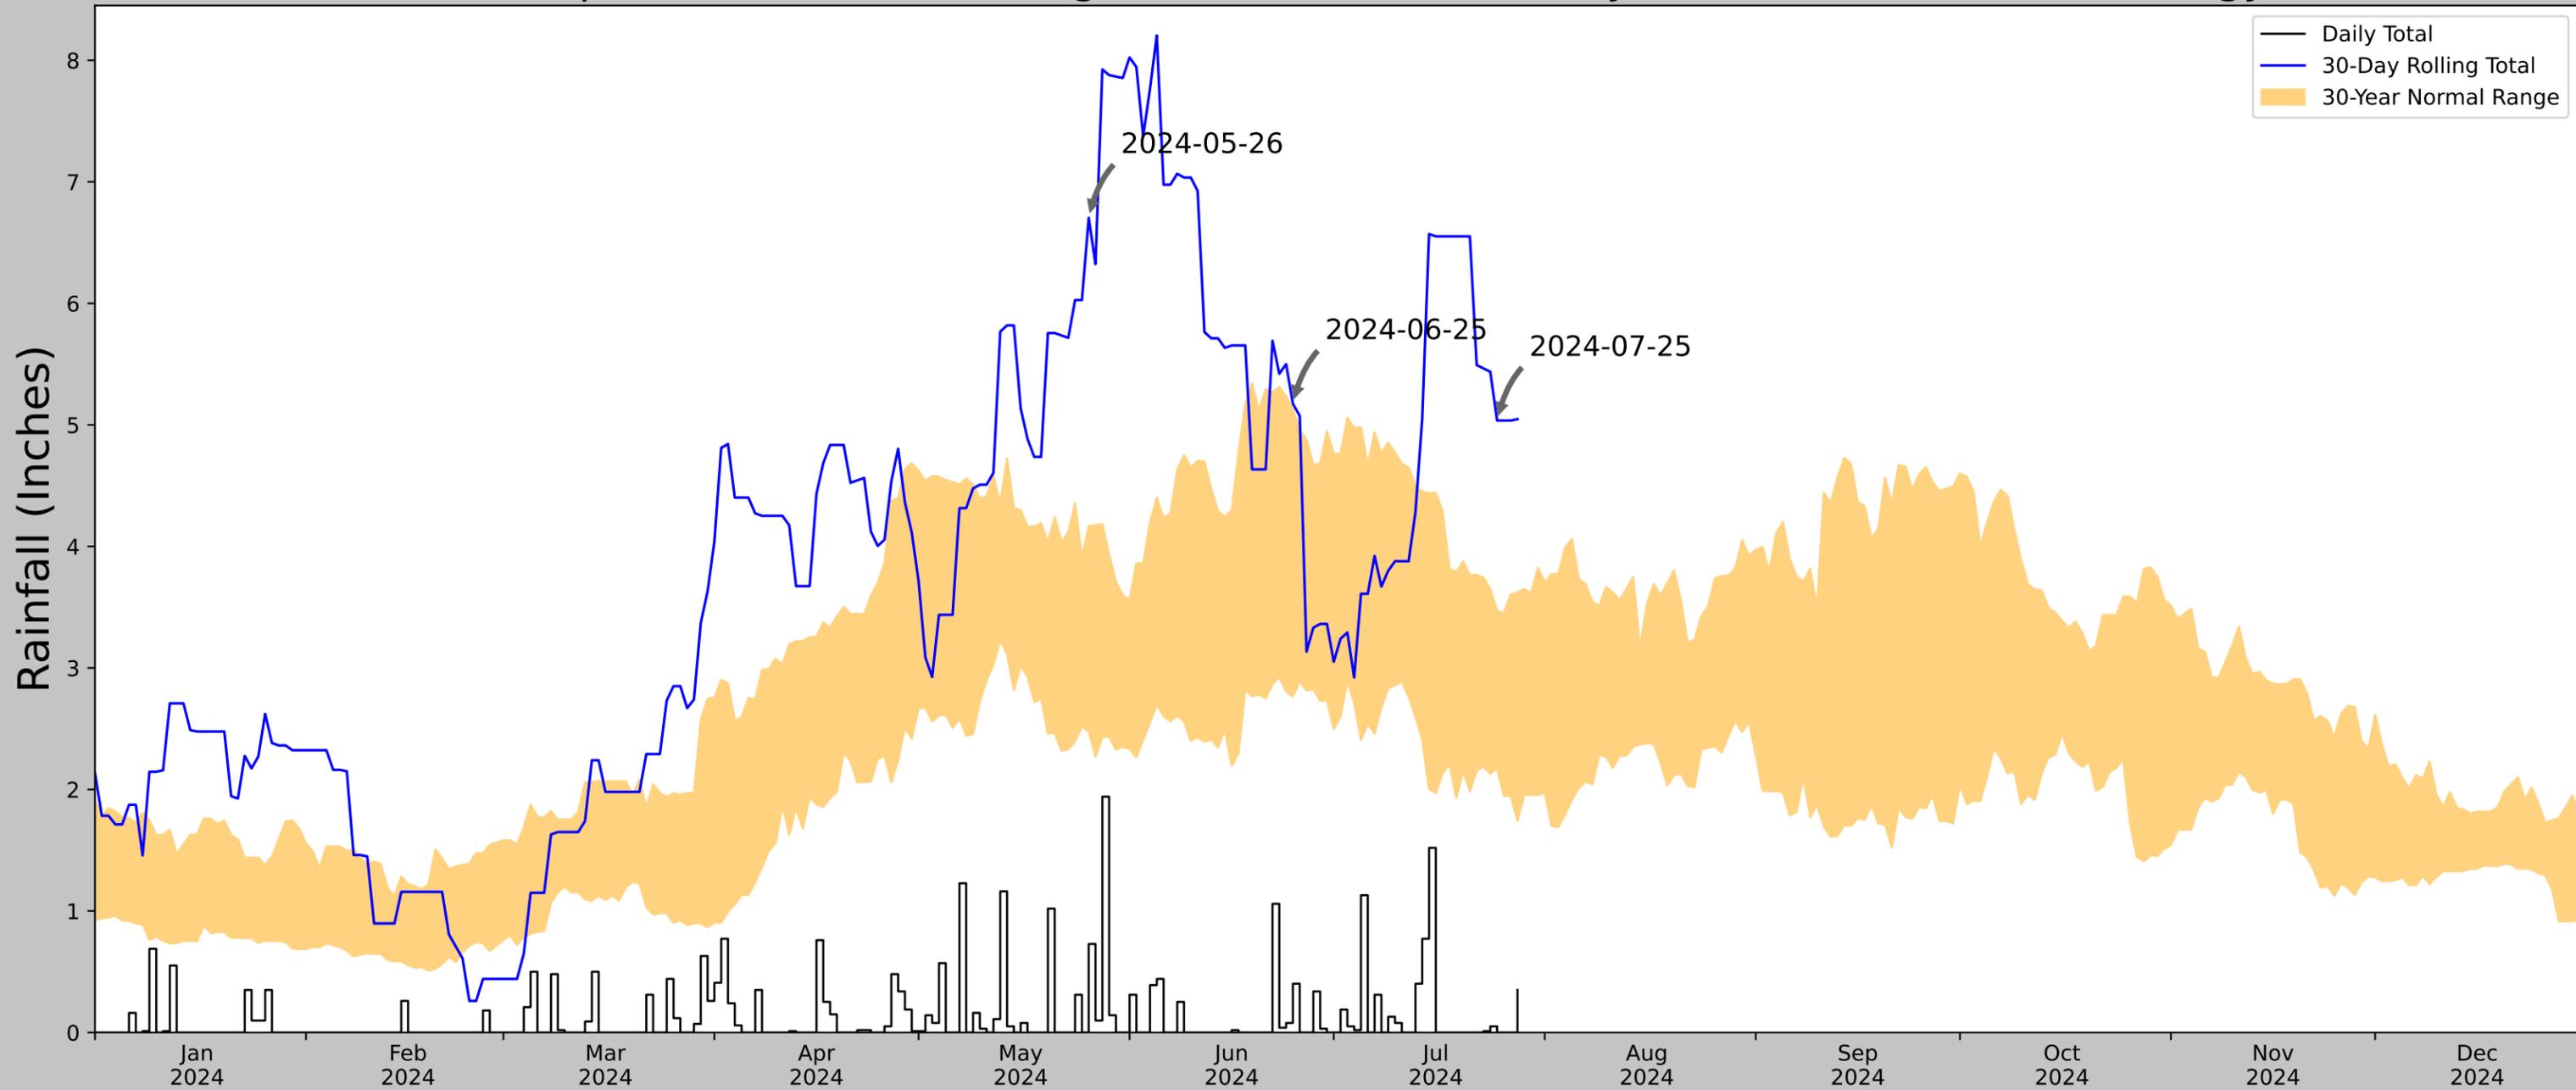
Antecedent Precipitation vs Normal Range based on NOAA's Daily Global Historical Climatology Network

| Coordinates | 42.575908, -87.958131 |
| Observation Date | 2024-07-25 |

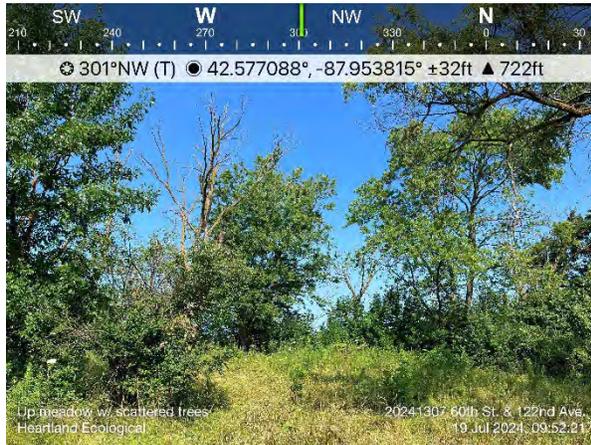
Photo #139 Upland meadow with scattered trees

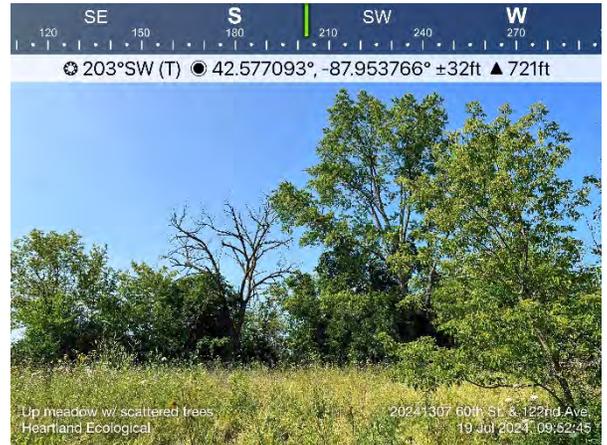
Photo #140 Upland meadow with scattered trees

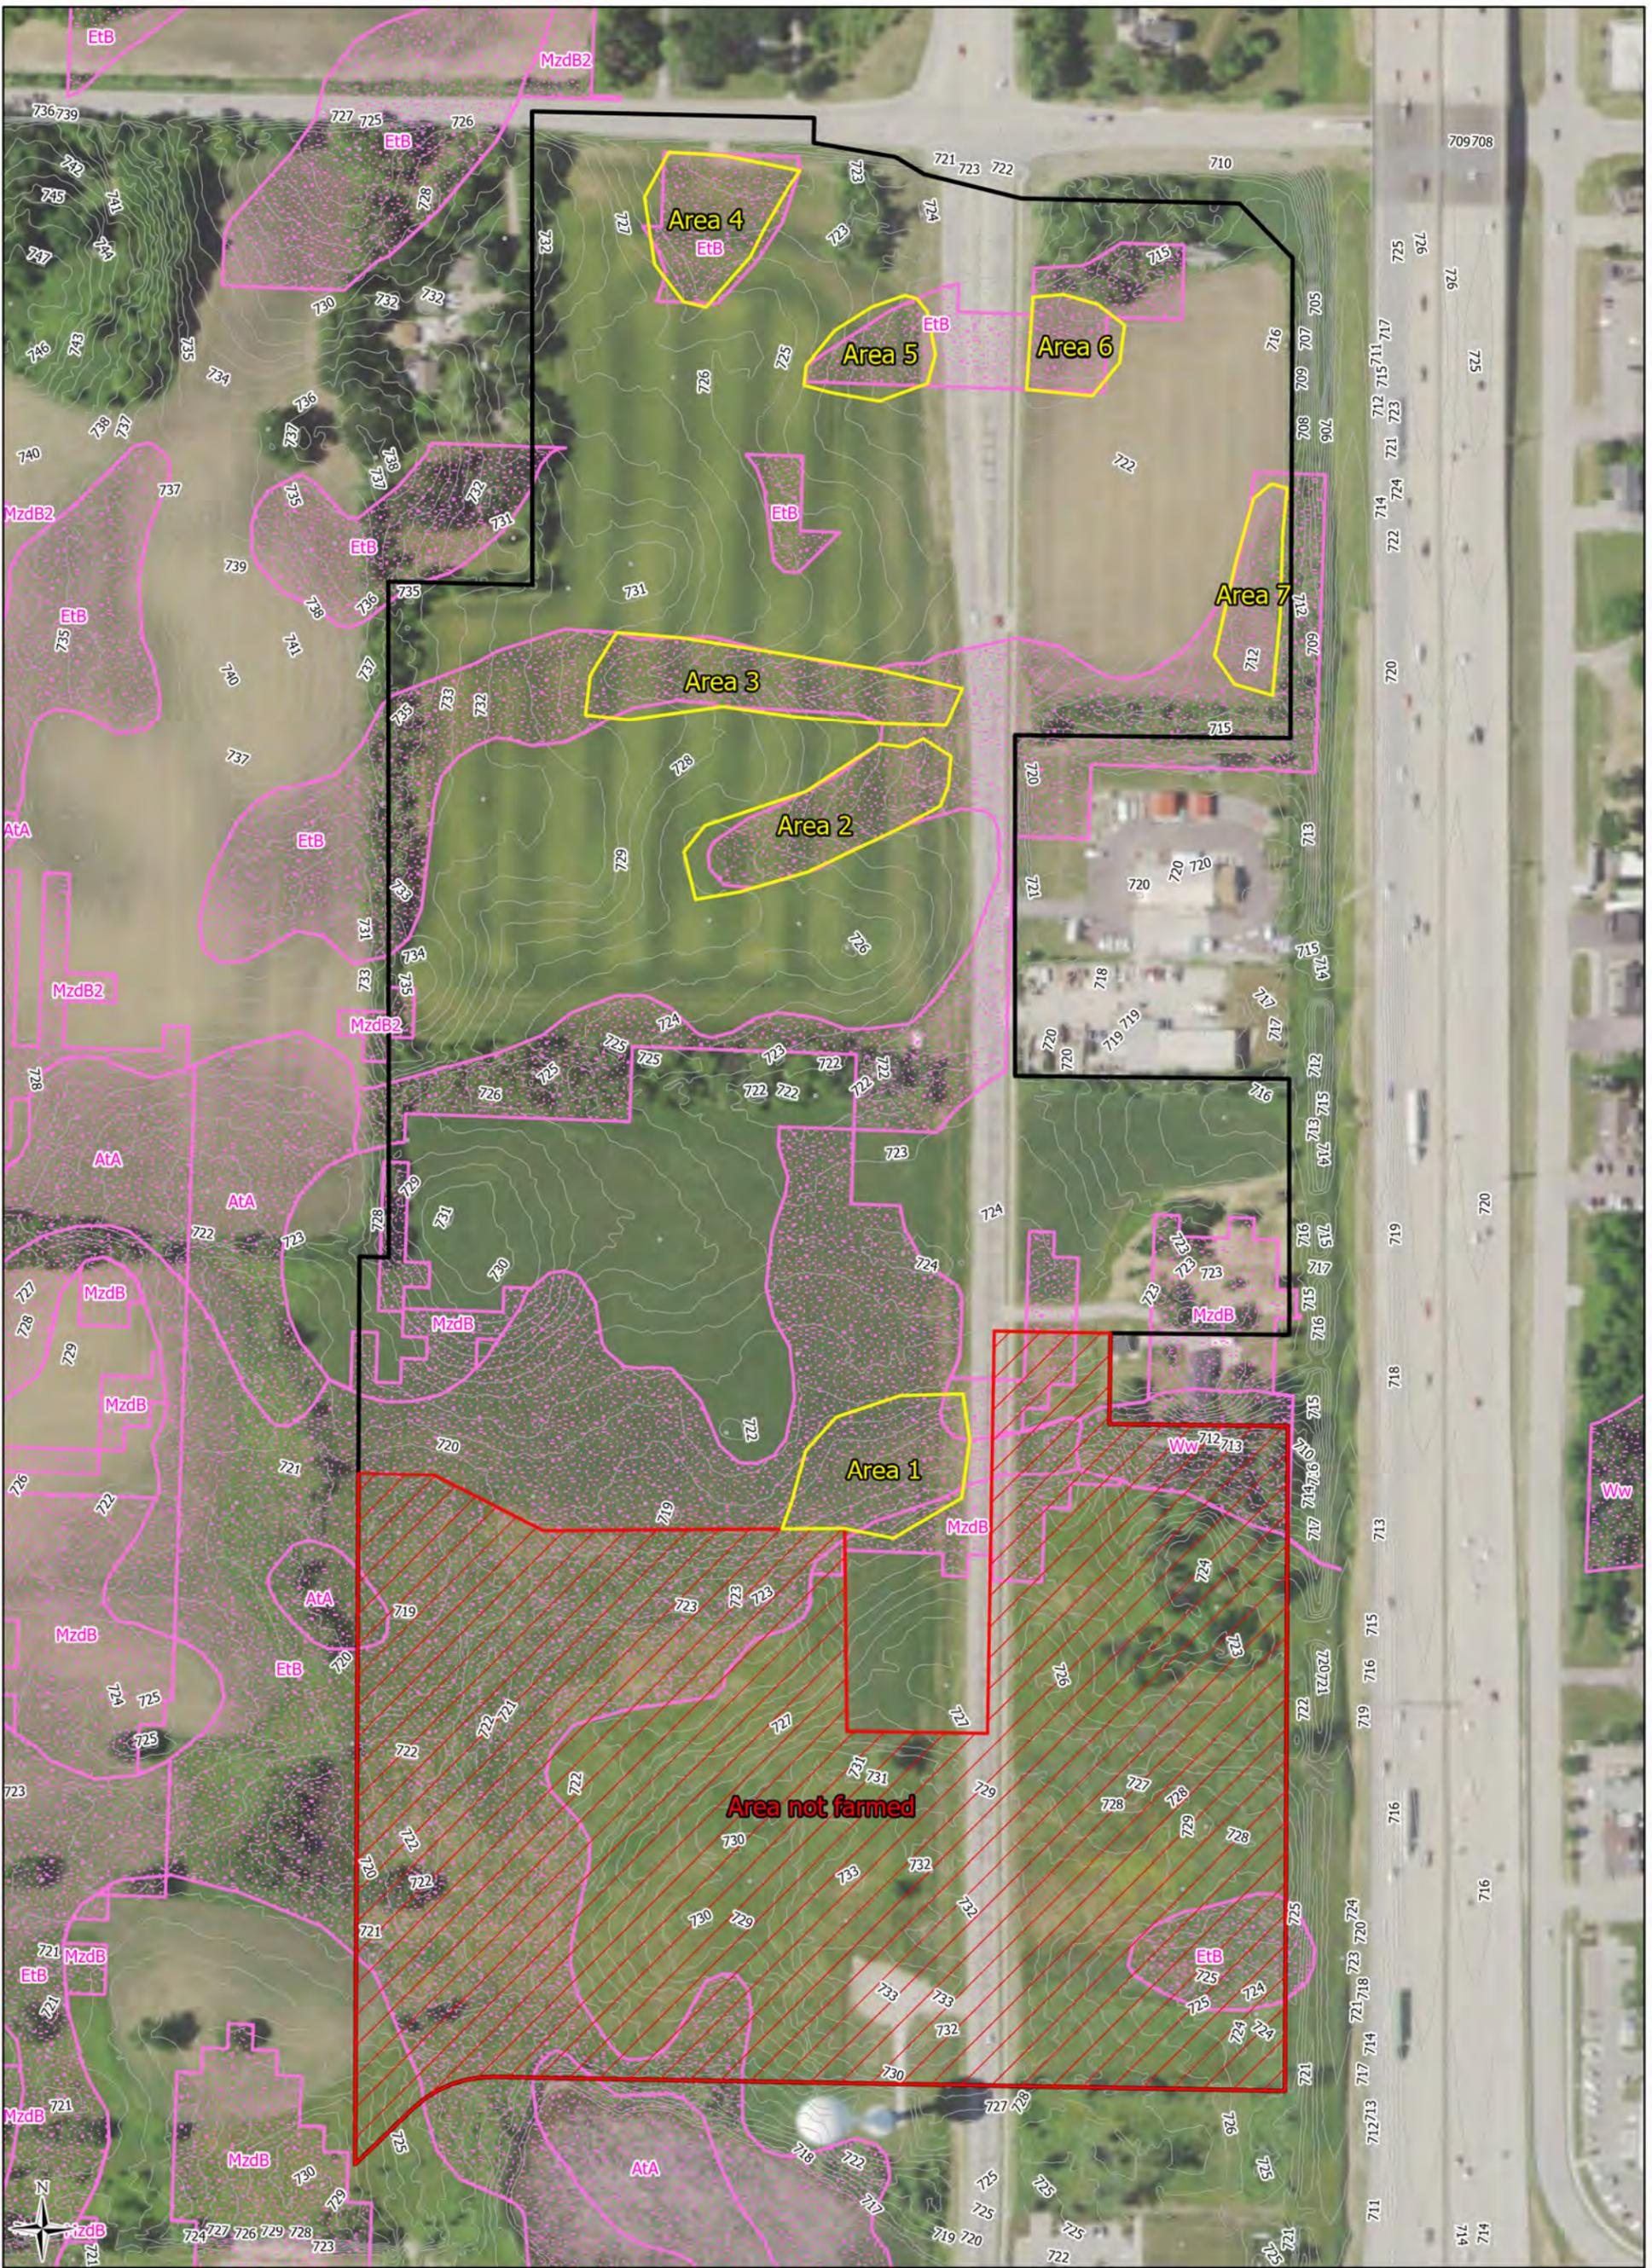
- Study Area (63.33 ac)
- OSA Review Area
- SWDV Wetland Indicators
- Kenosha Co 1' Contours

Agricultural fields are present within the Study Area and have significant mapped hydric or potentially hydric soils and were the focus of the Off-Site Analysis (OSA) (Appendix F). From the aerial imagery, the secondary wetland hydrology indicators of "Saturation Visible on Aerial Imagery" (C9) and "Stunted or Stressed Plants" (D1) were noted in three (3) areas.

A total of 18 aerial images were selected and reviewed based on availability and quality of the imagery. Of these images, ten (10) were taken under normal antecedent precipitation conditions. Signatures were noted in seven (7) areas within the Study Area within landscape positions described by the NRCS to support hydric soil components and were the focus of the OSA. At least one (1) of the seven (7) described wetland signatures per the July 2016 Guidance were consistently noted in three (3) of these areas on imagery taken under normal antecedent precipitation conditions. In imagery taken under wet antecedent precipitation conditions, such wetland signatures were noted in five (5) of the six (6) images. In imagery taken under dry antecedent precipitation conditions, there were wetland signatures noted in two (2) of the two (2) images.

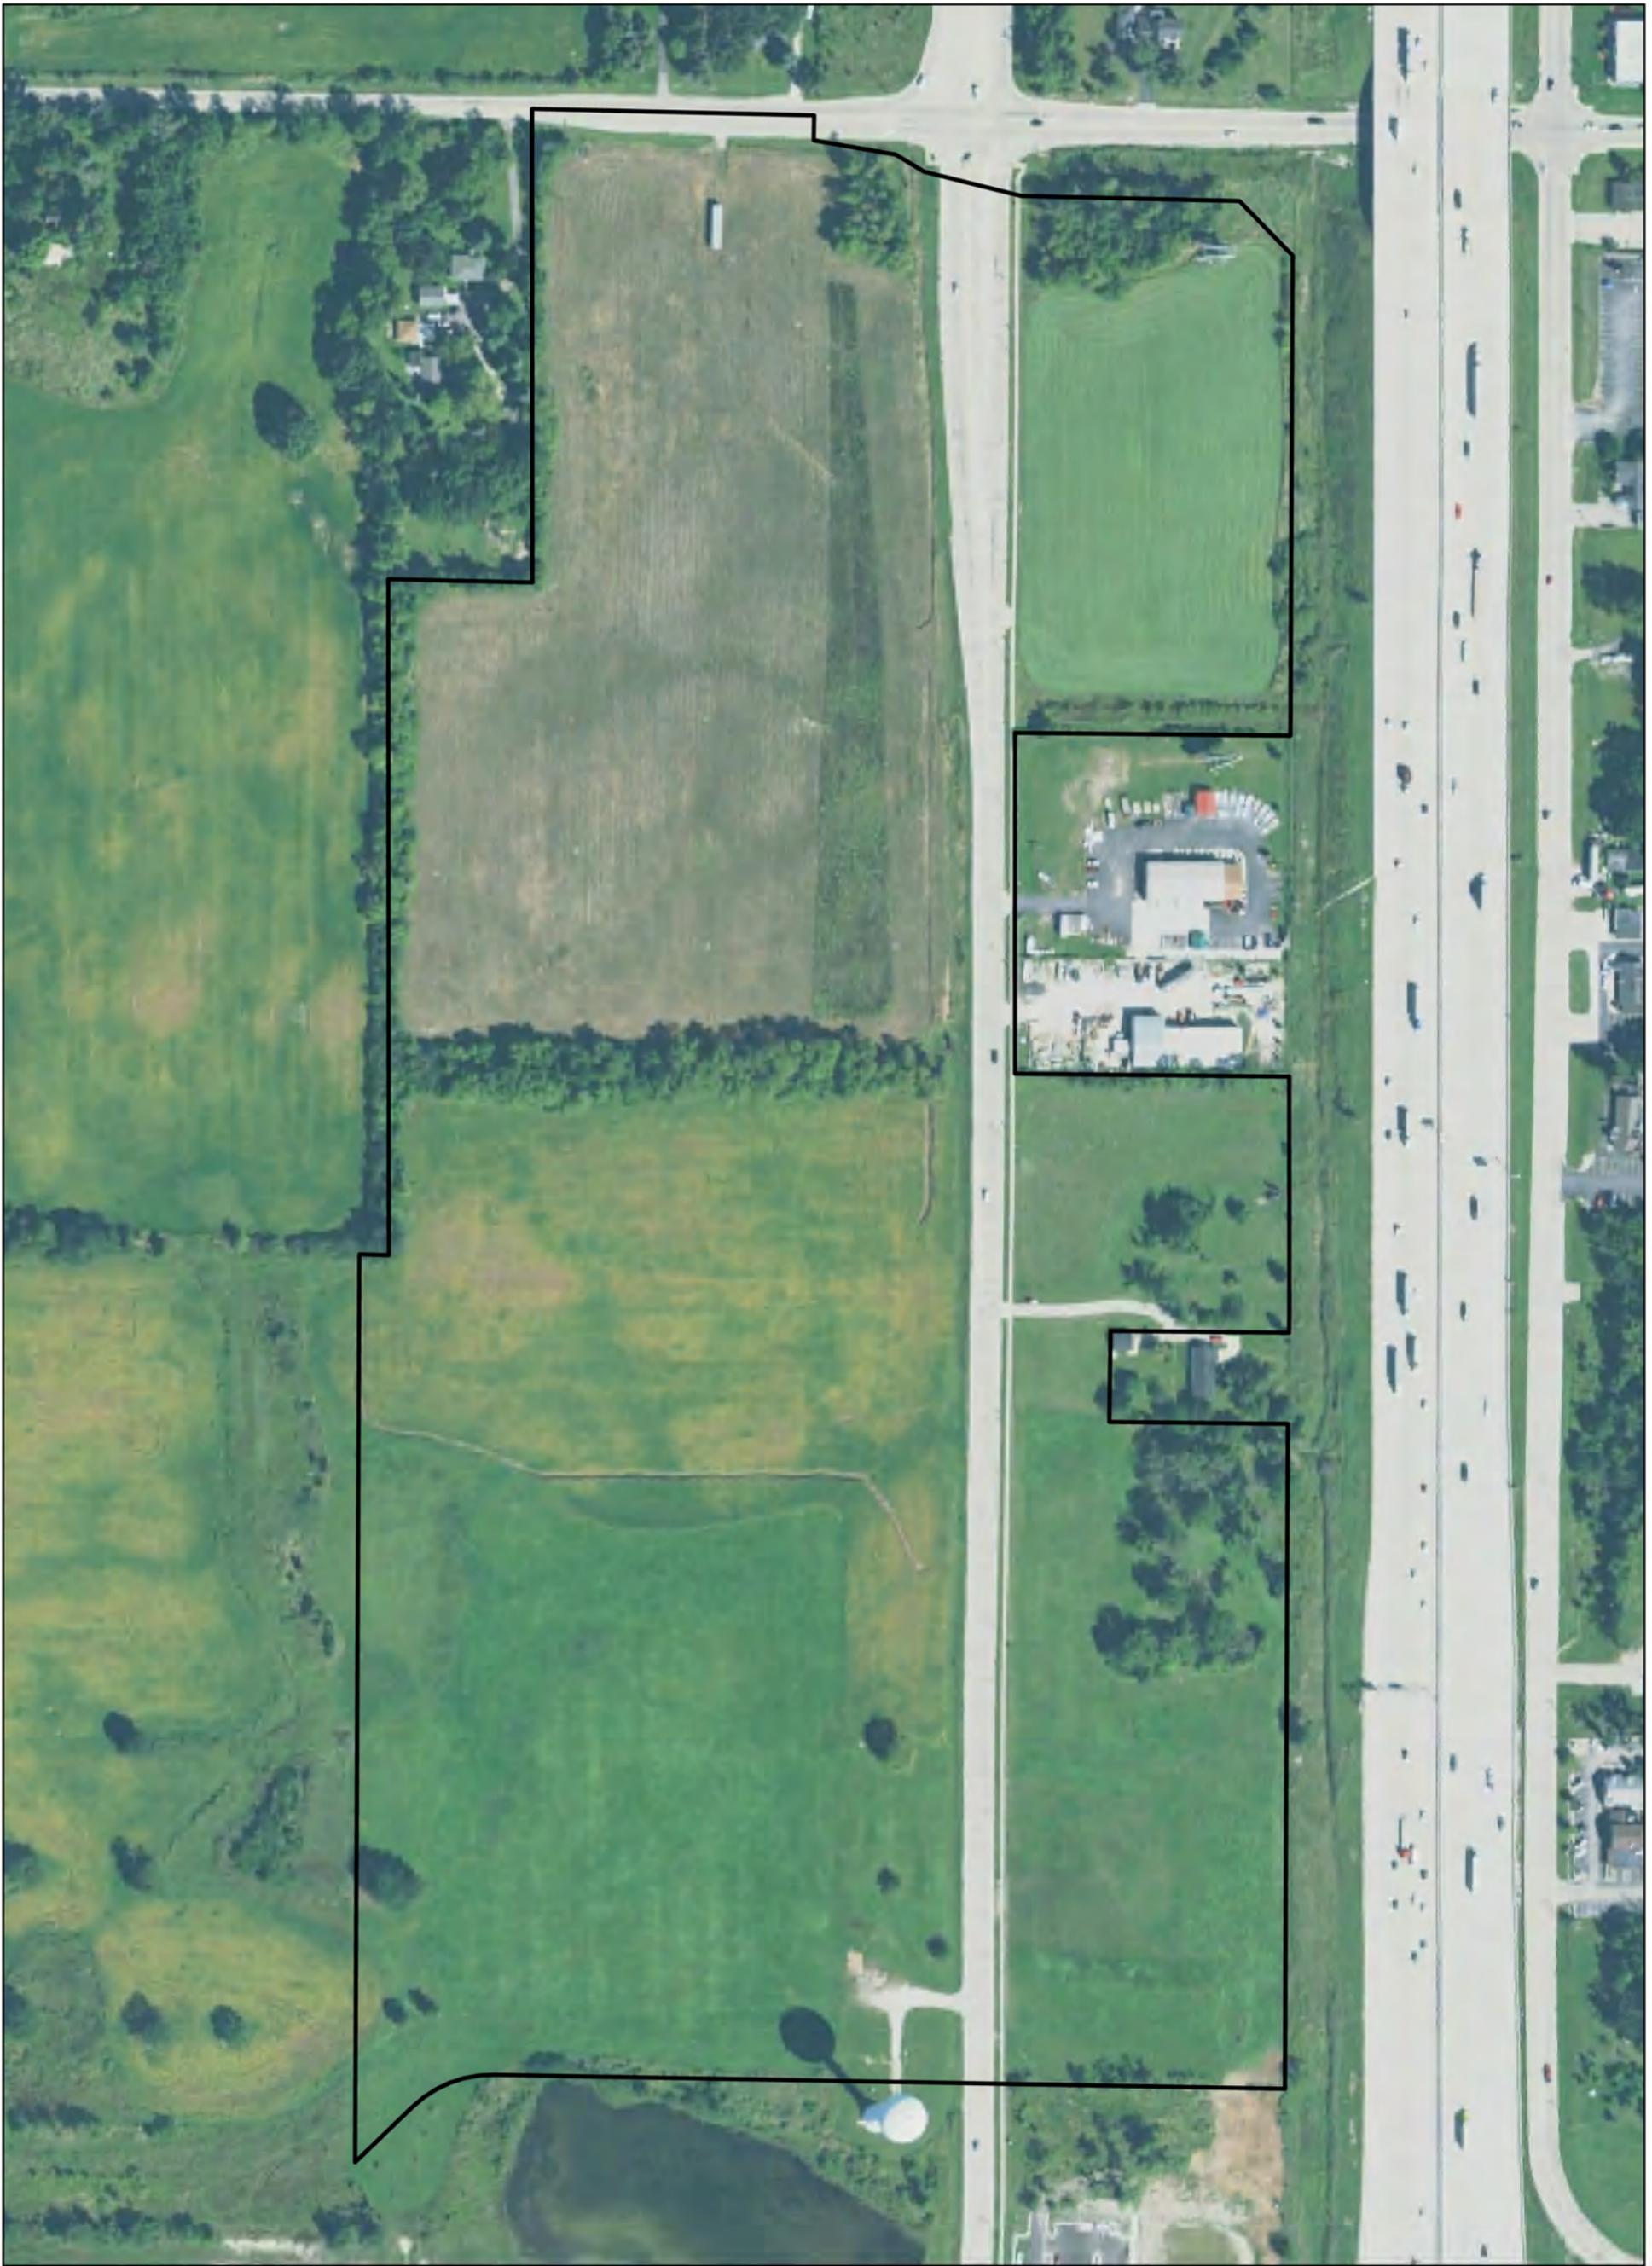
Appendix: 2017-09-22
NAIP Aerial Imagery
60th St. and 122nd Ave.
Project #20241307
T1N, R21E, S1
C Kenosha, Kenosha Co

2017 NAIP
USDA

Study Area (63.33 ac)

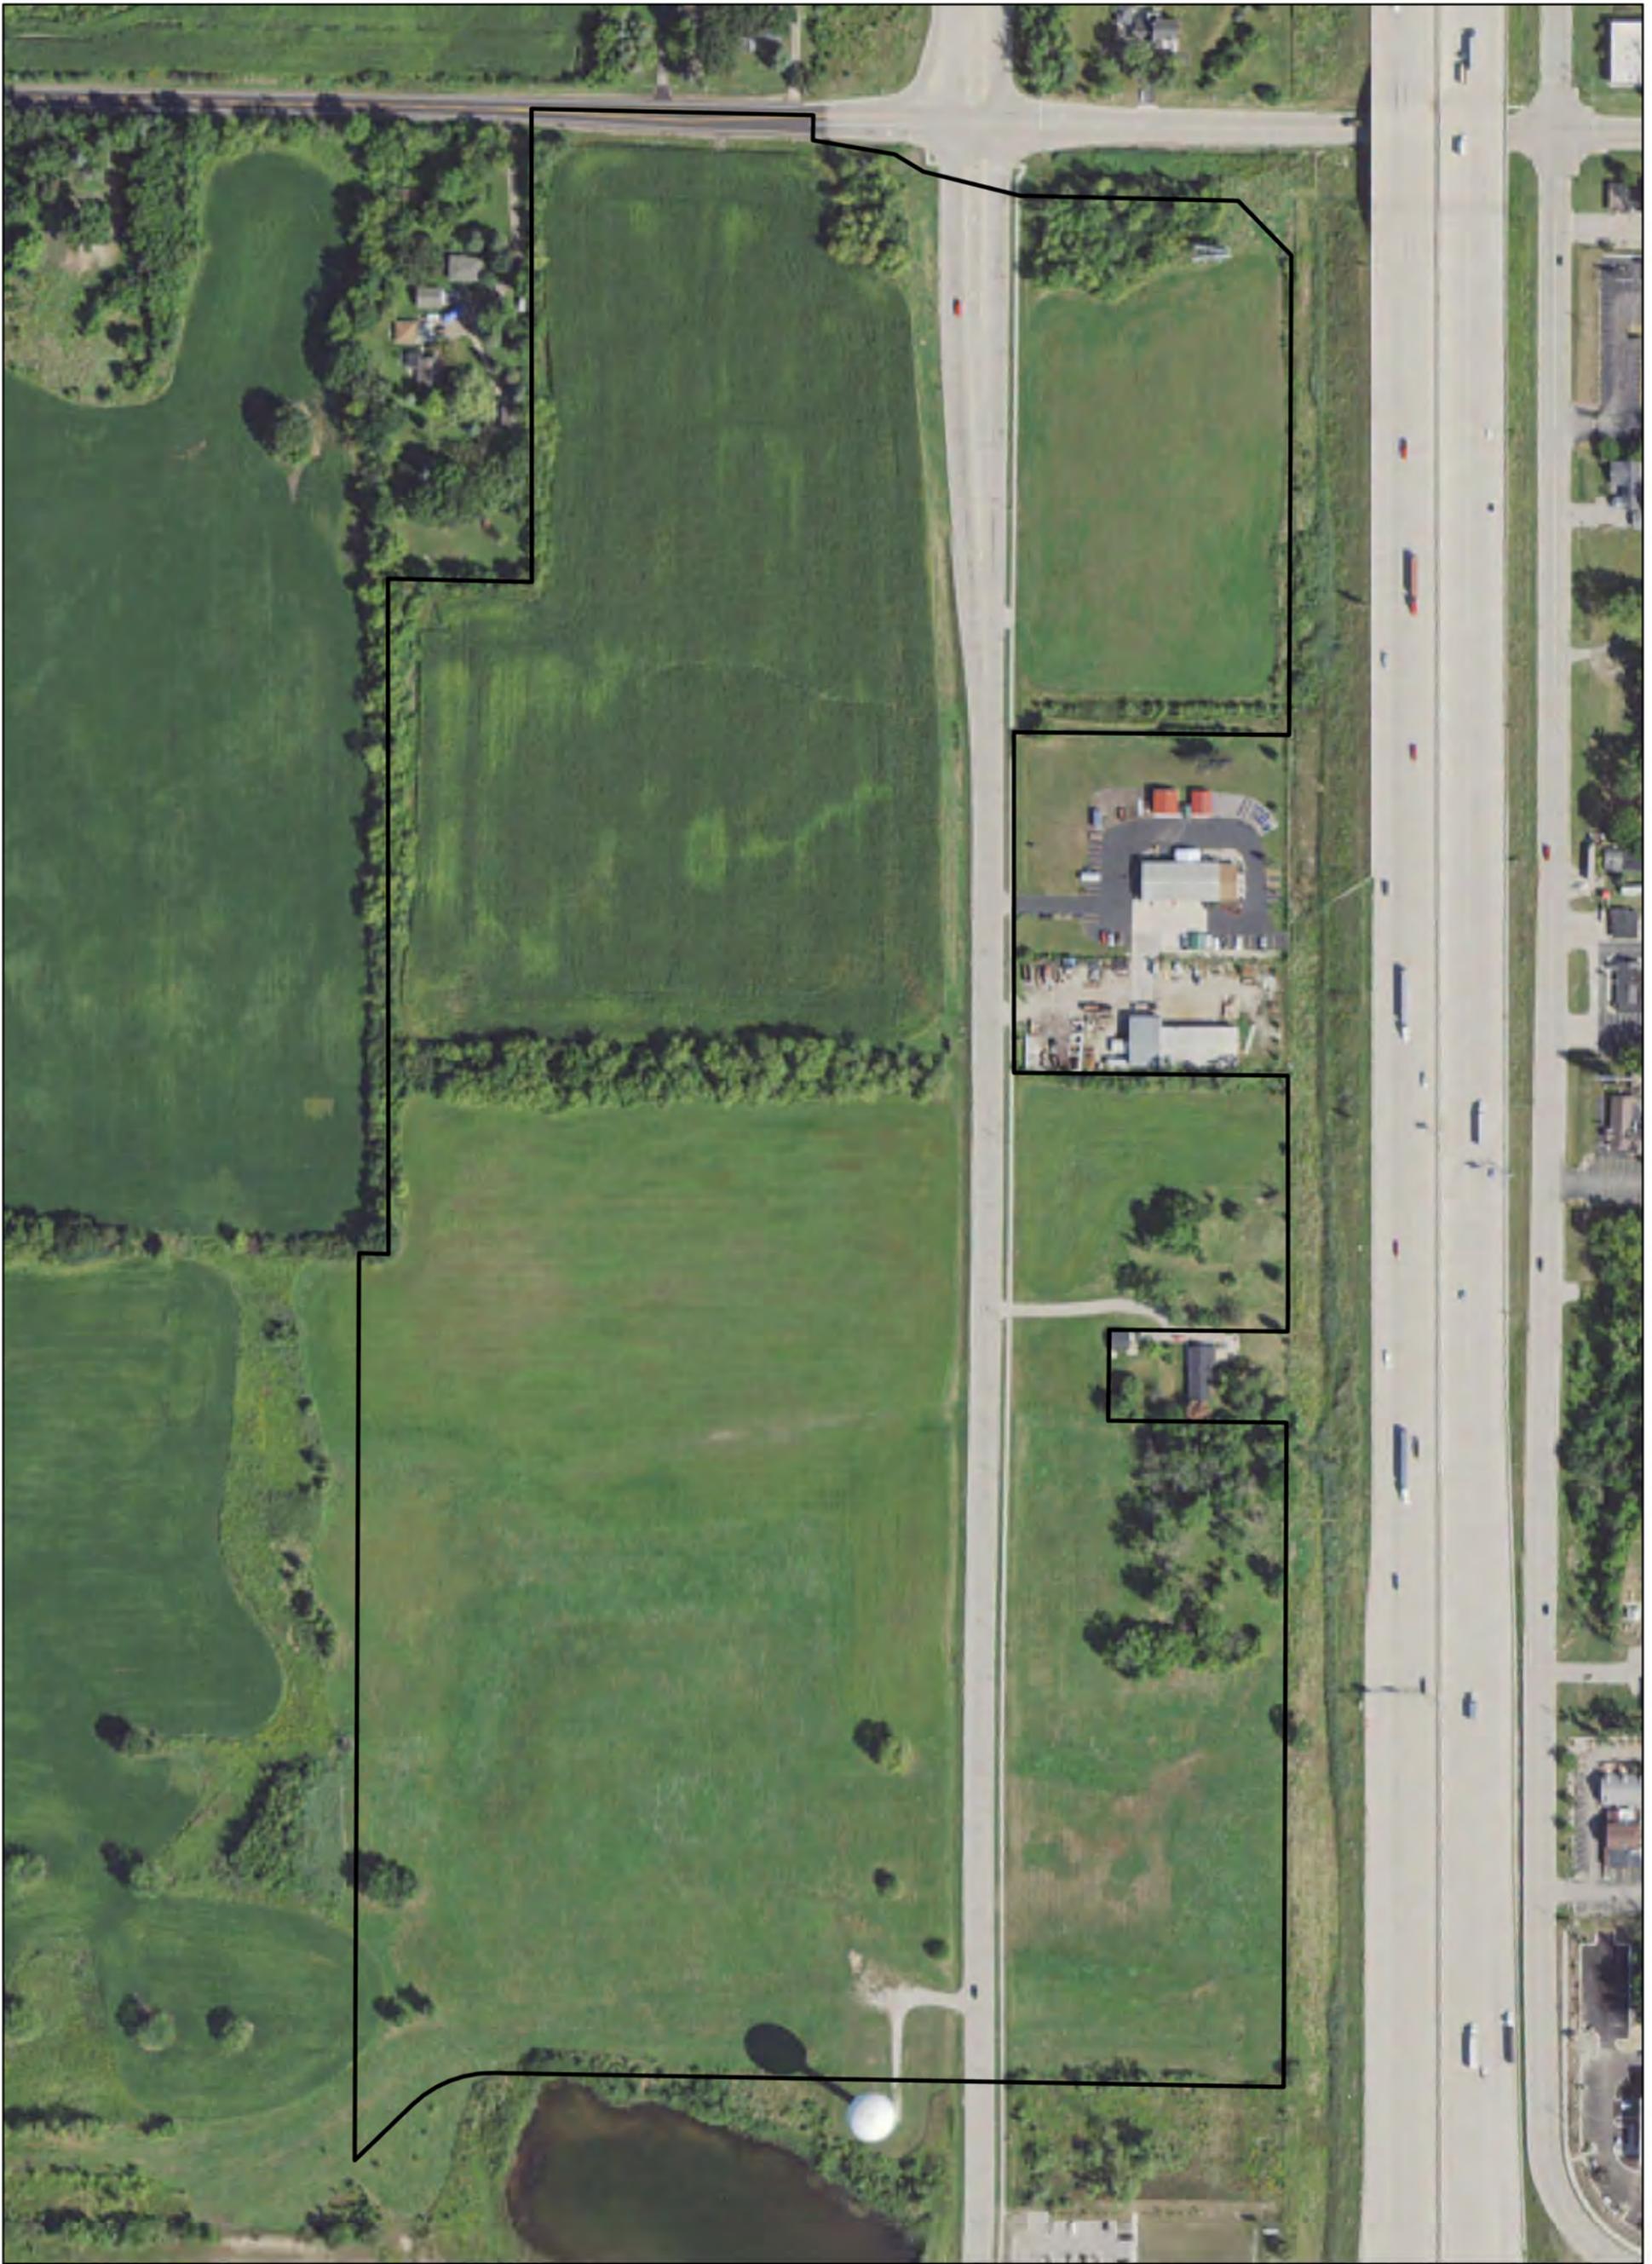
2018 NAIP
USDA

Study Area (63.33 ac)
