APPENDIX BIO

BIOLOGICAL RESOURCE DOCUMENTS

Montrose Environmental Solutions
60th Street and 122nd Avenue Parcels
Project #: 20241307
August 1, 2024

Appendix A | Figures

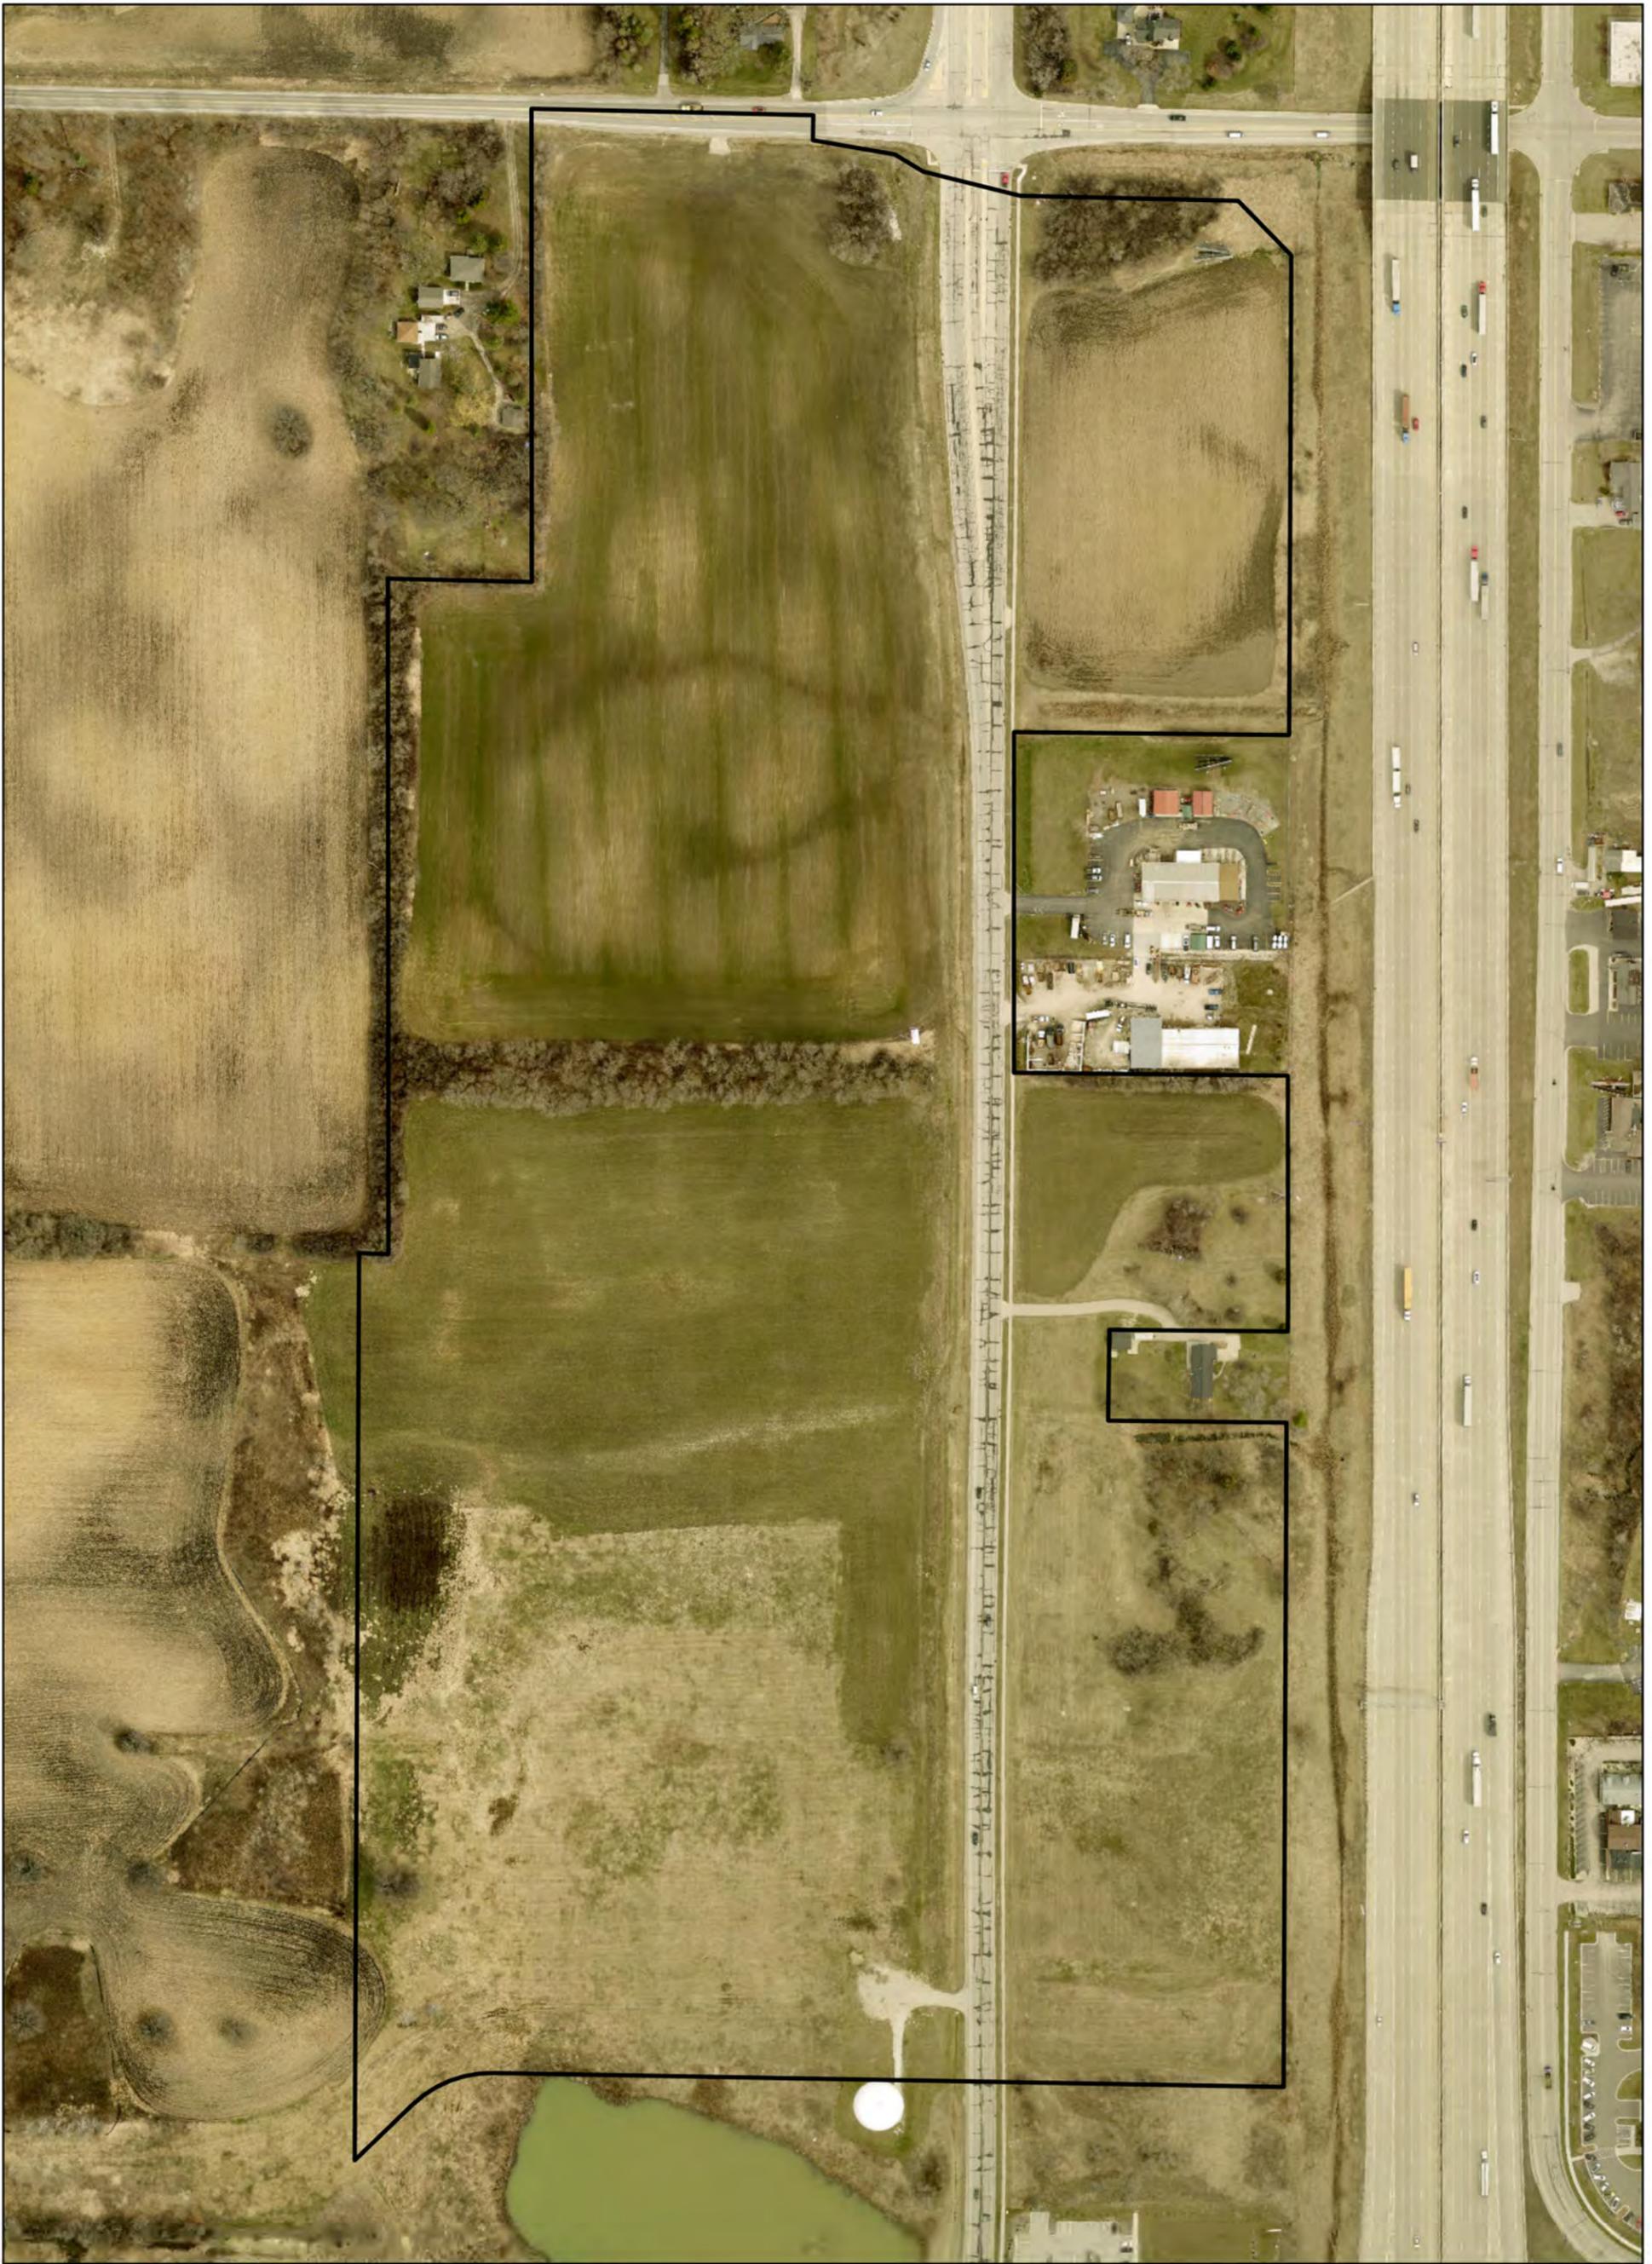
Appendix: 2020-09-02
NAIP Aerial Imagery
60th St. and 122nd Ave.
Project #20241307
T1N, R21E, S1
C Kenosha, Kenosha Co

2020 NAIP
USDA

Study Area (63.33 ac)

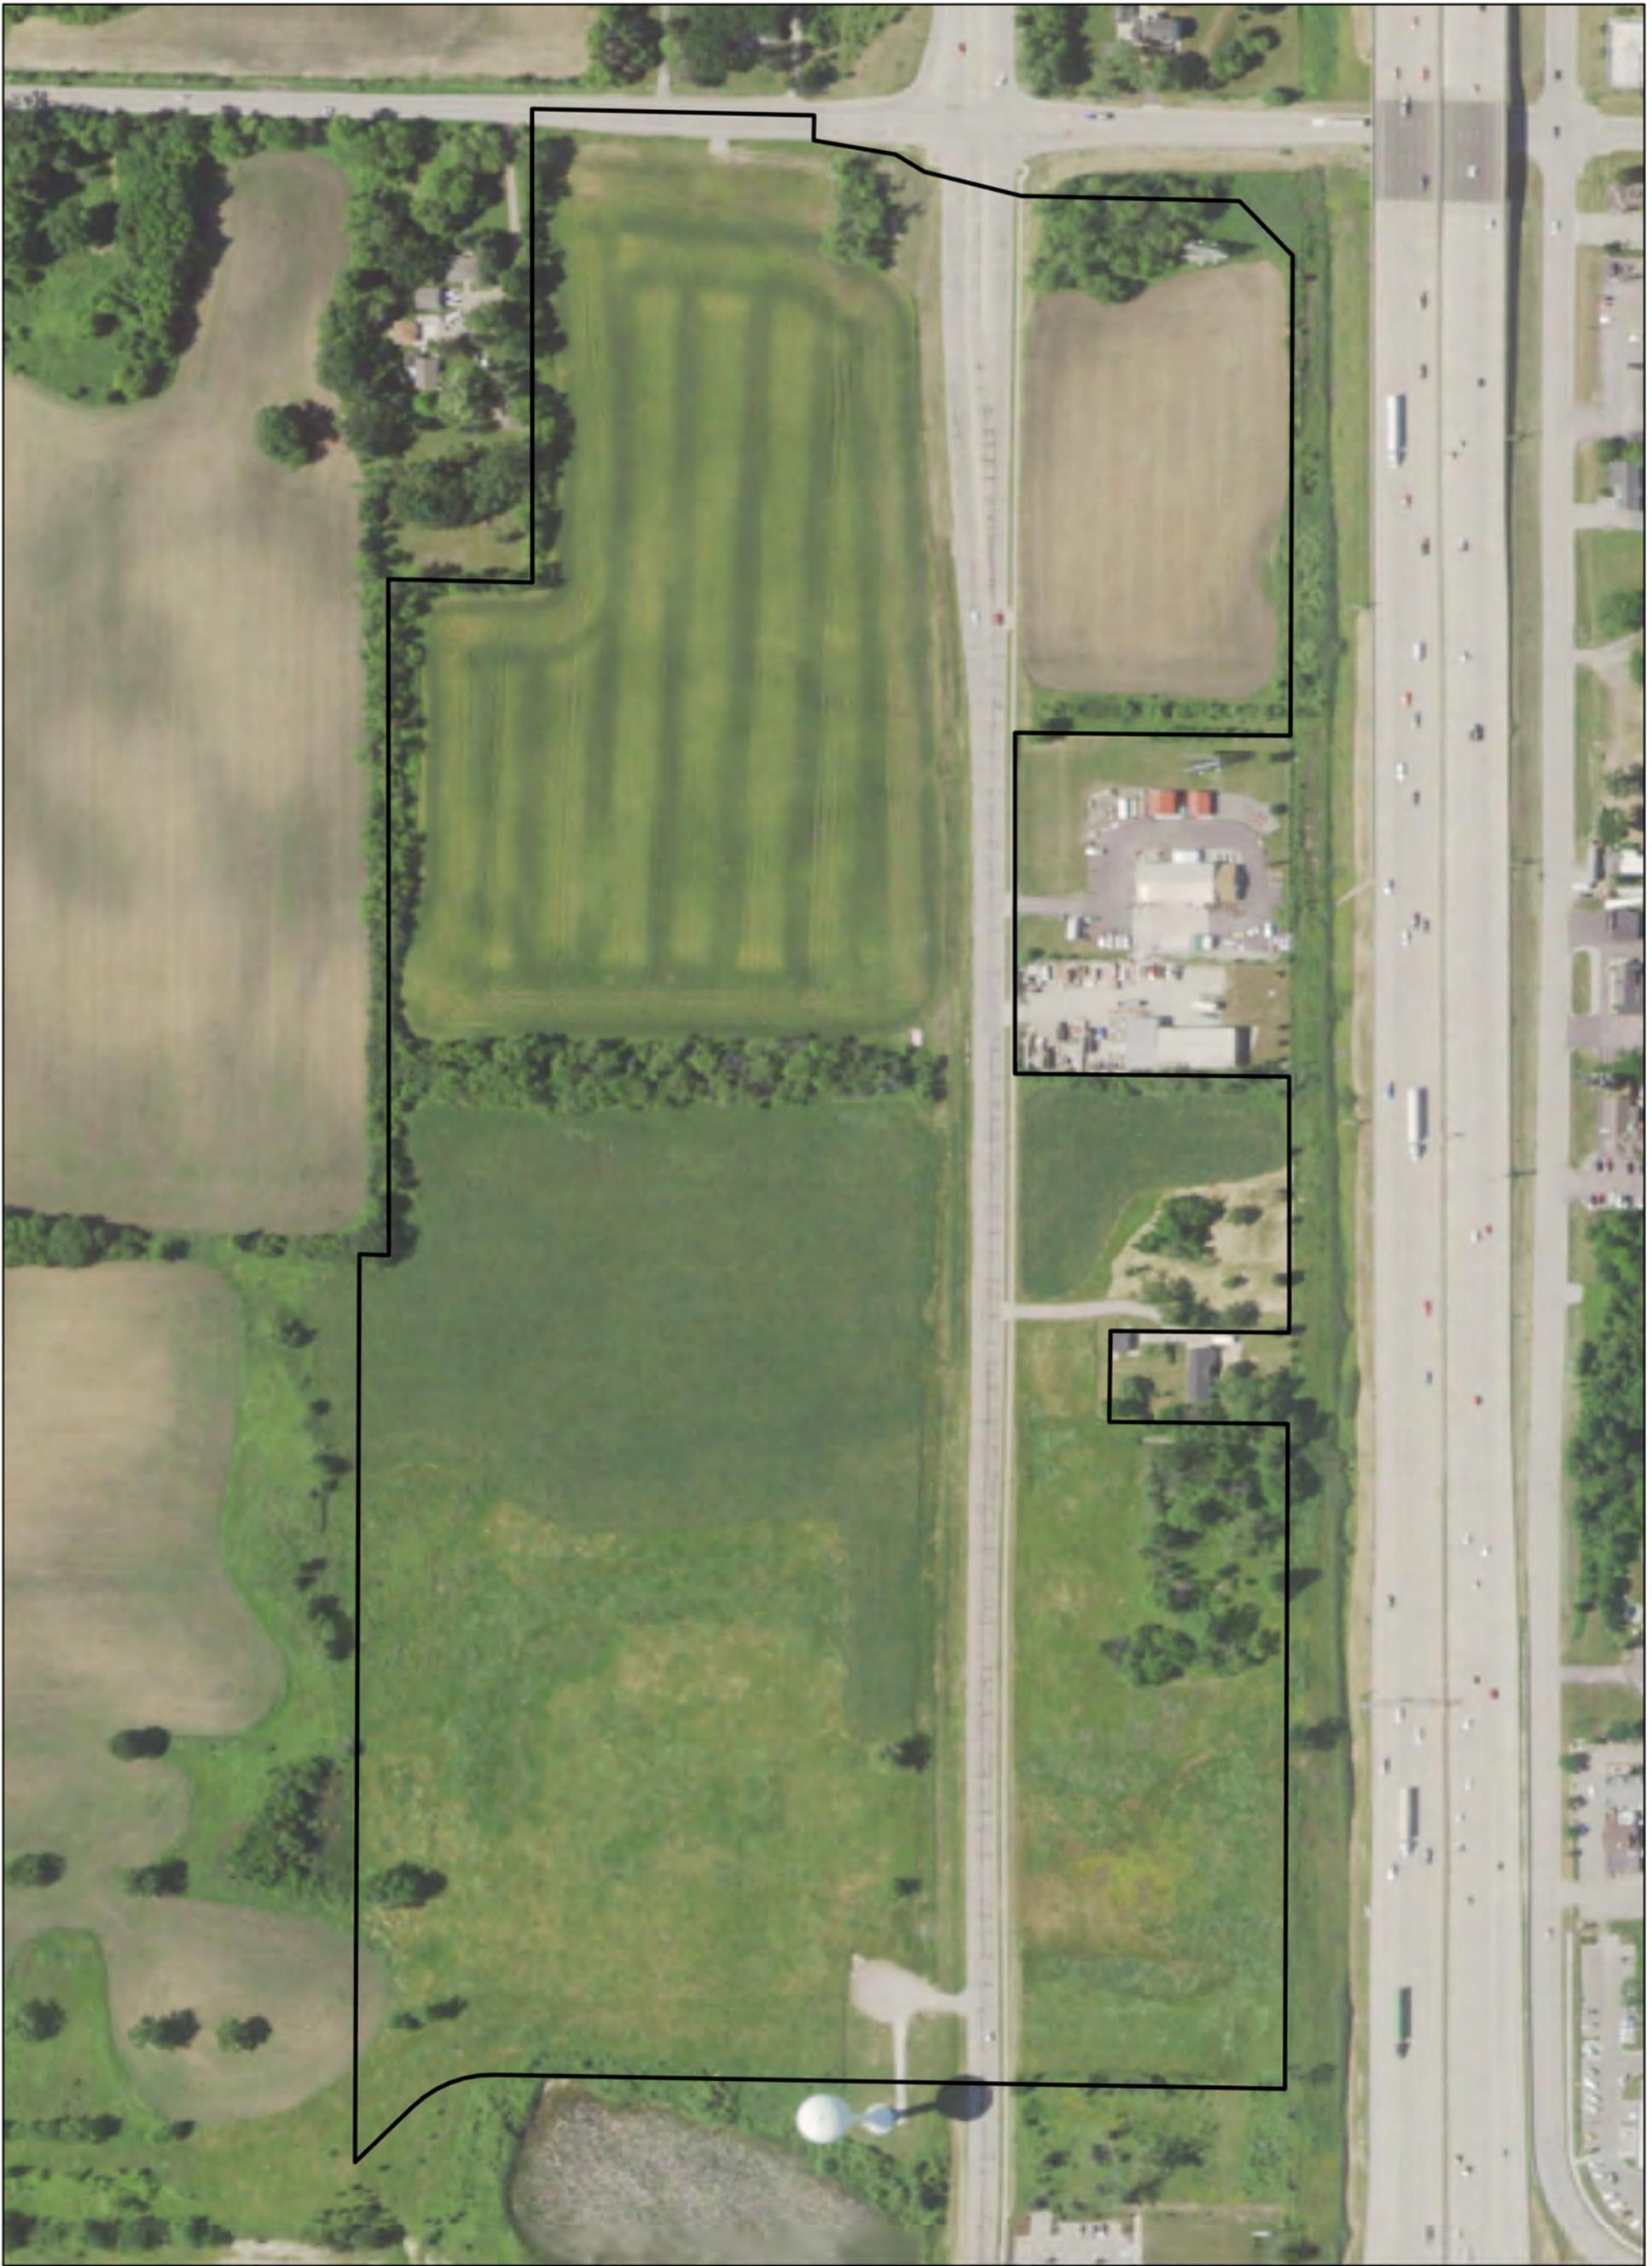
Appendix: 2022-05-01
Maxar Sat. Imagery
60th St. and 122nd Ave.
Project #20241307
T1N, R21E, S1
C Kenosha, Kenosha Co

2022 Sat. Imagery
Maxar
Figure Created: 7/15/2024

Study Area (63.33 ac)

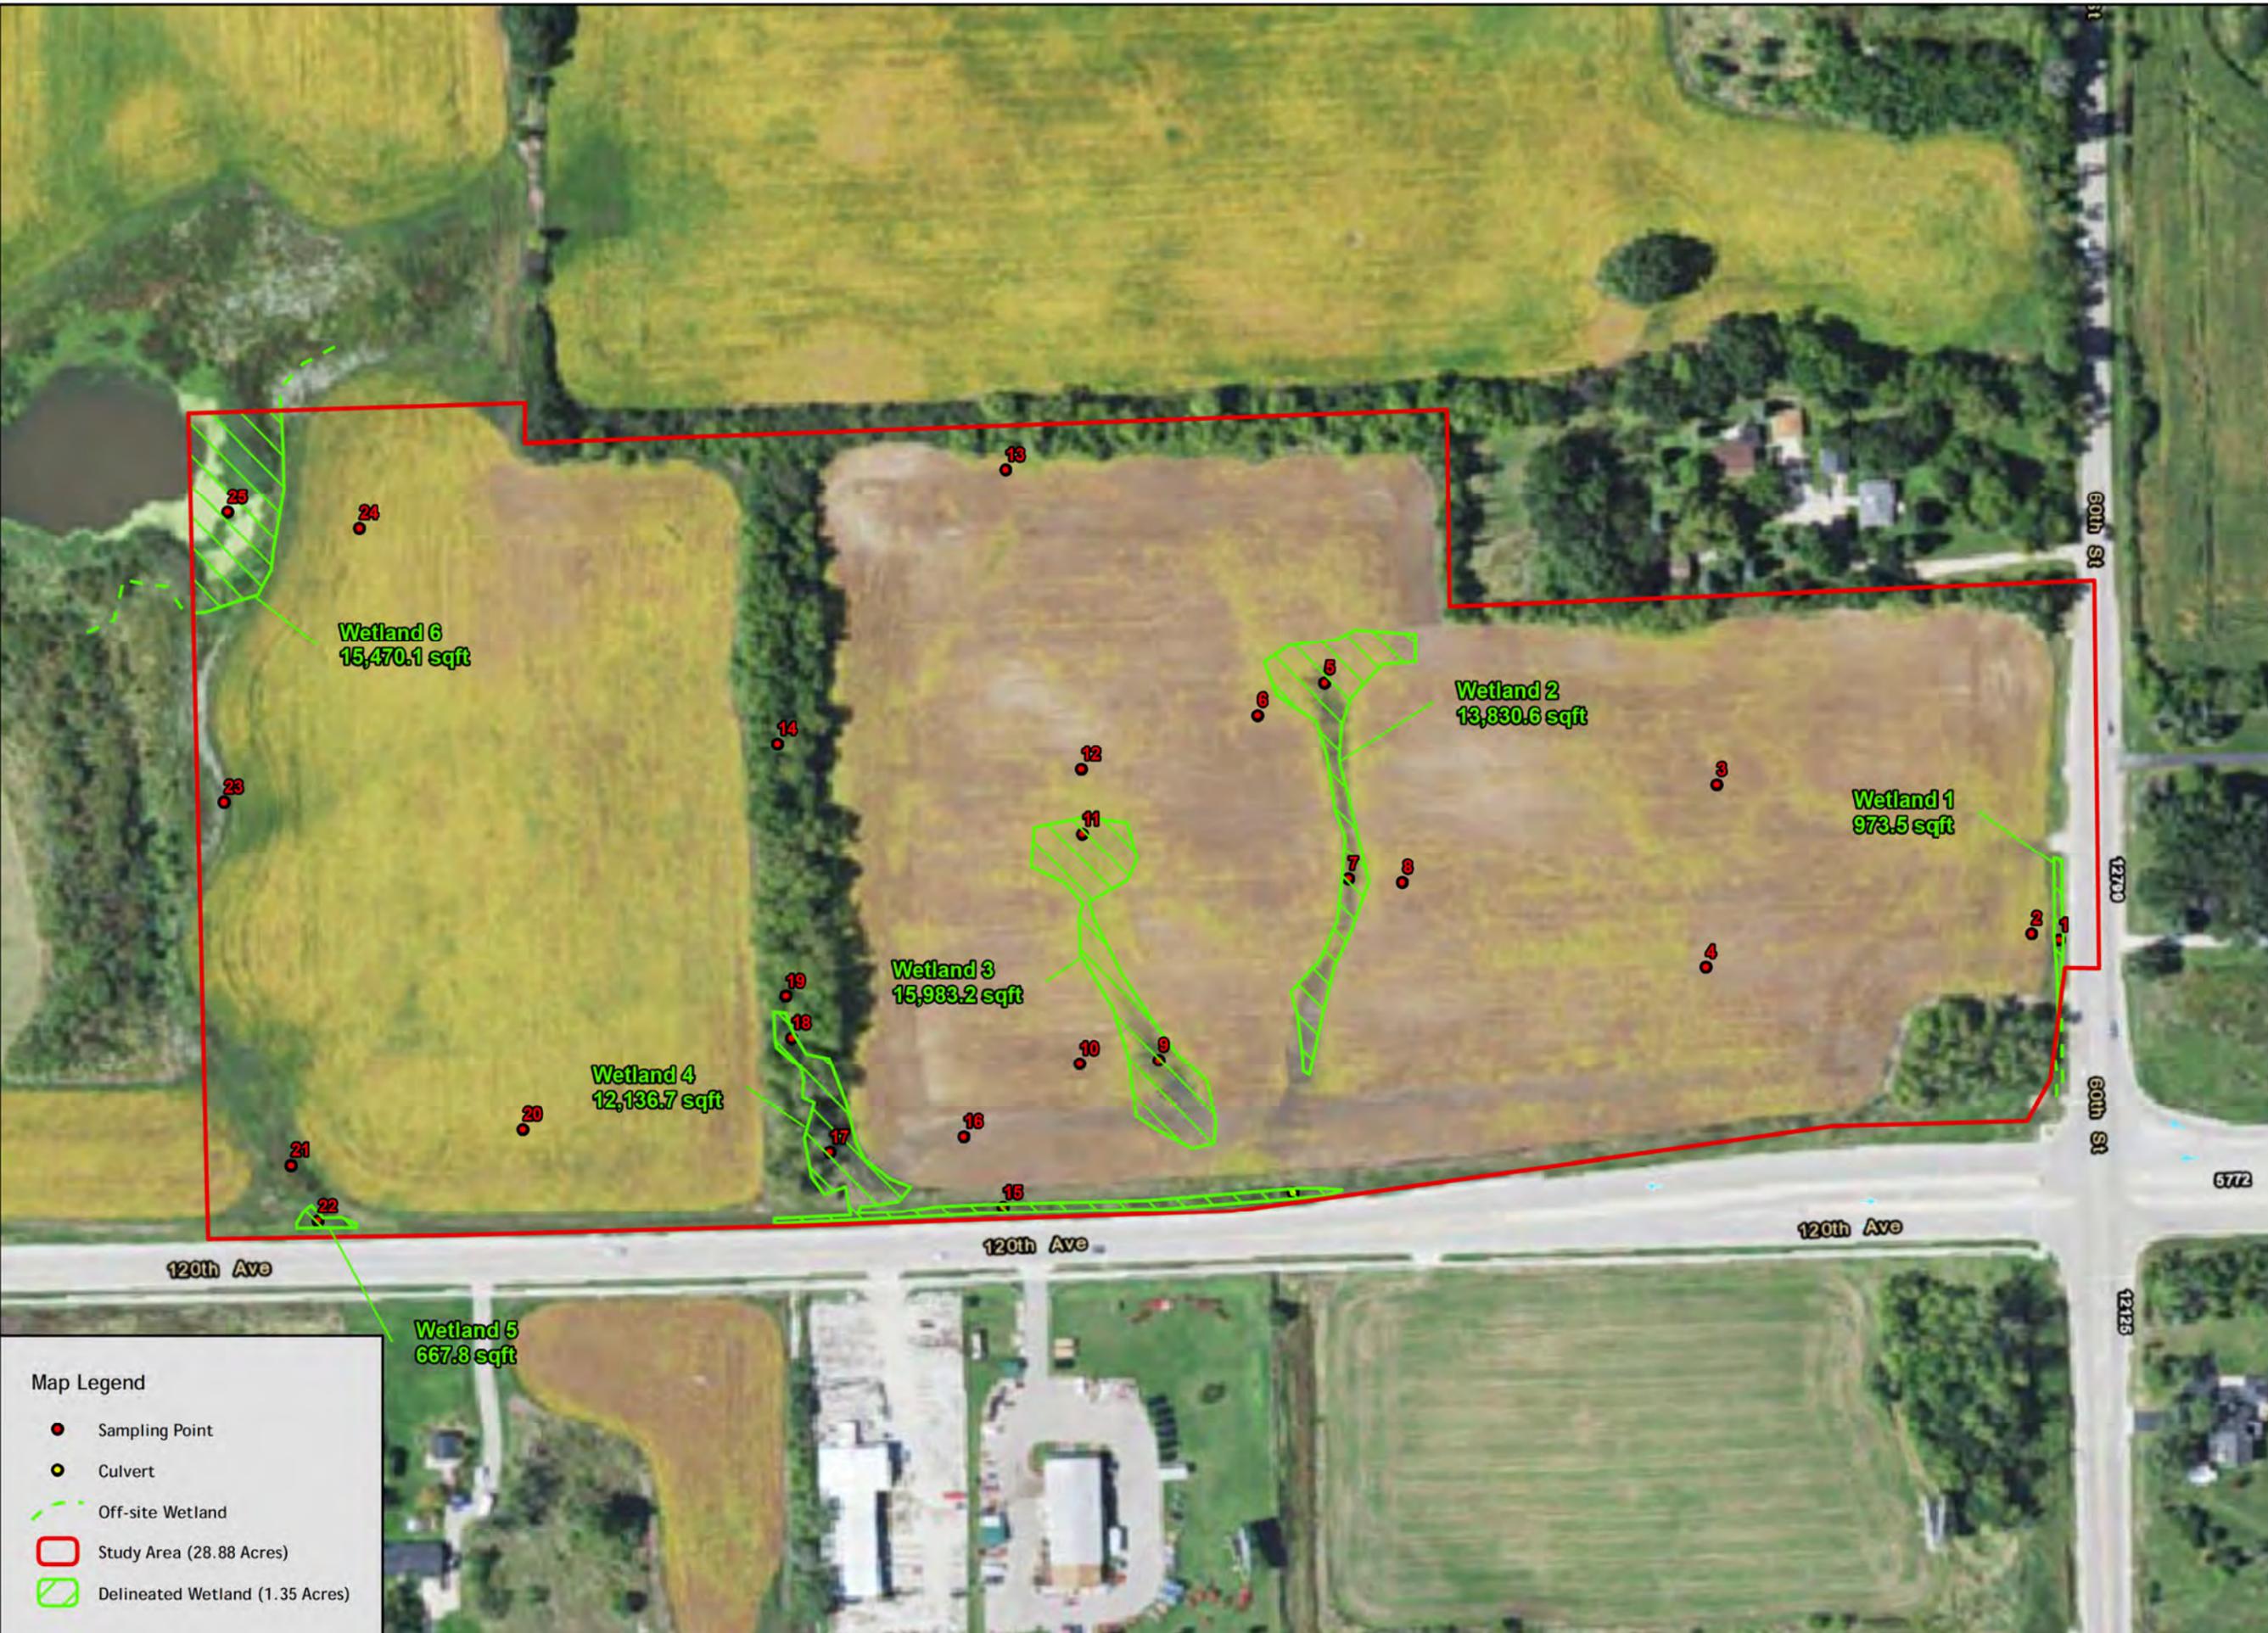
Figure 2
Wetland Boundary
Map

- Sampling Point
- Culvert
- - - Off-site Wetland
- ▭ Study Area (28.88 Acres)
- ▨ Delineated Wetland (1.35 Acres)

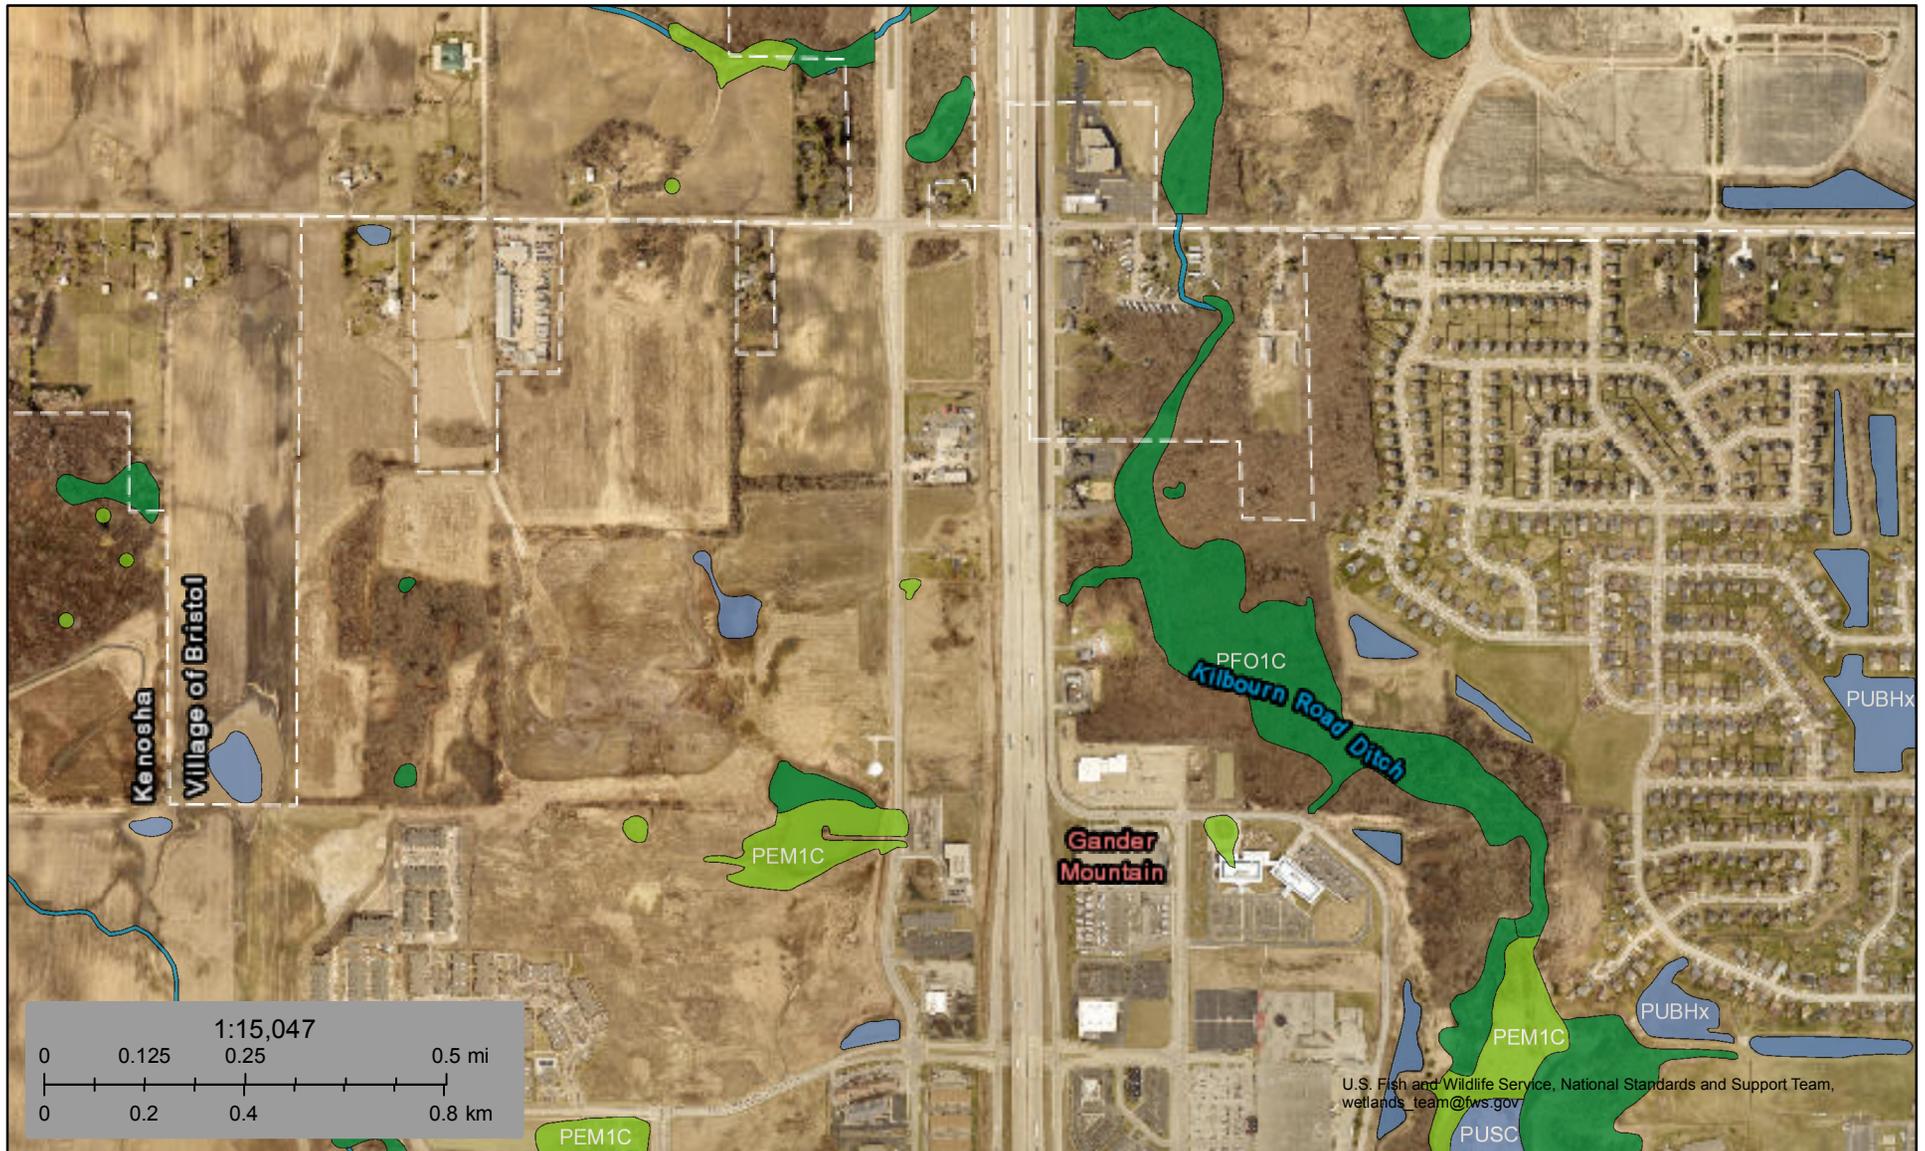
NWI – NATIONAL WETLAND INVENTORY

Wetlands
